TECHNICAL STUDY
FOR REHABILITATION
ON PRAMBANAN TEMPLE COMPOUND
AFTER EARTHQUAKE

BY
TECHNICAL STUDY TEAM
ARCHAEOLOGICAL OFFICE OF YOGYAKARTA

DEPARTMENT OF CULTURE AND TOURISM
2007

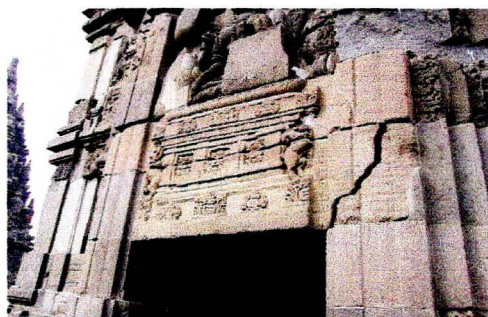
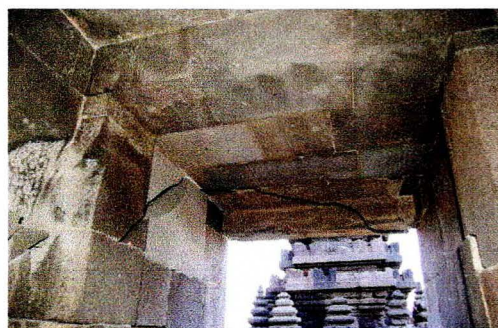
On Siwa temple the sink down occurs at the four stairways, about 2 cm deep. It makes horizontal crack on the balustrade doorway, exactly between the body and the roof of the doorway. Horizontal and vertical cracks occurs from the foot of the temple through the floor, up to the body of the temple. The cracks can be observed on the whole 30 sections. There is a significant crack that encircles the lower body of the temple, from the 1st to the 20th plane. This crack is accompanied by horizontal outward move about 2 cm – 5 cm.

Cracks on the outer wall and alley of west gate way of Siwa Temple.

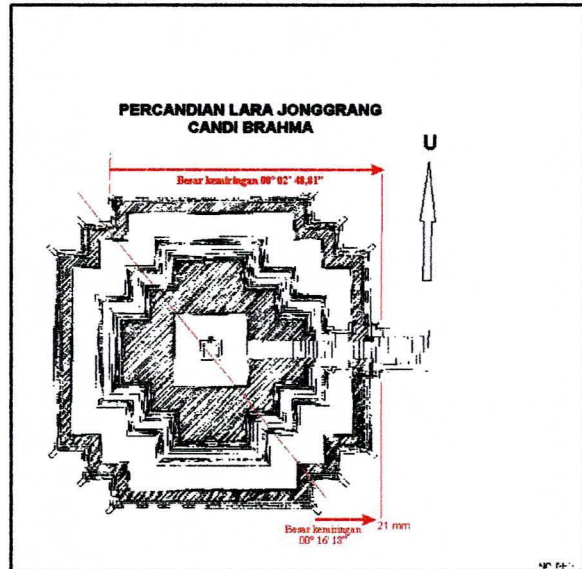
Brahma Temple

The types of structural damage are : sink downwards, horizontal move, and vertical and horizontal cracks. On Brahma temple there are sink downwards about 2 cm at the east staircase towards the south-east as far as the 1st – 5th and the 20th sections. The sink down is accompanied by vertical and horizontal cracks. Horizontal move occurs at the balustrade and the doorway, third and fourth stories of the roof. There is also twist caused by cracks, and horizontal and vertical cracks.

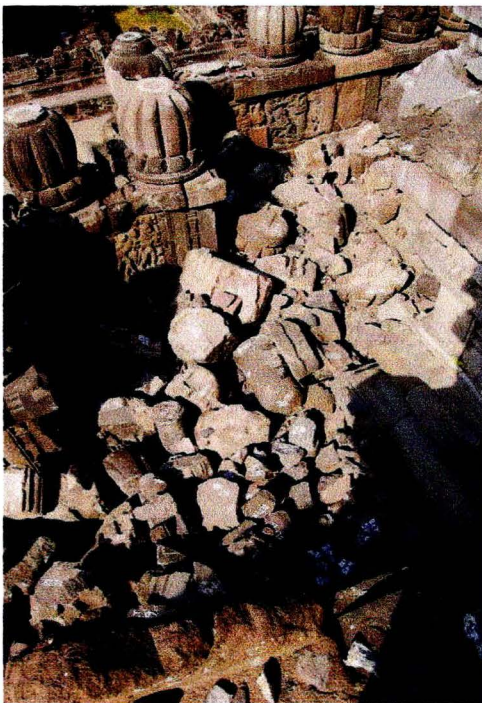
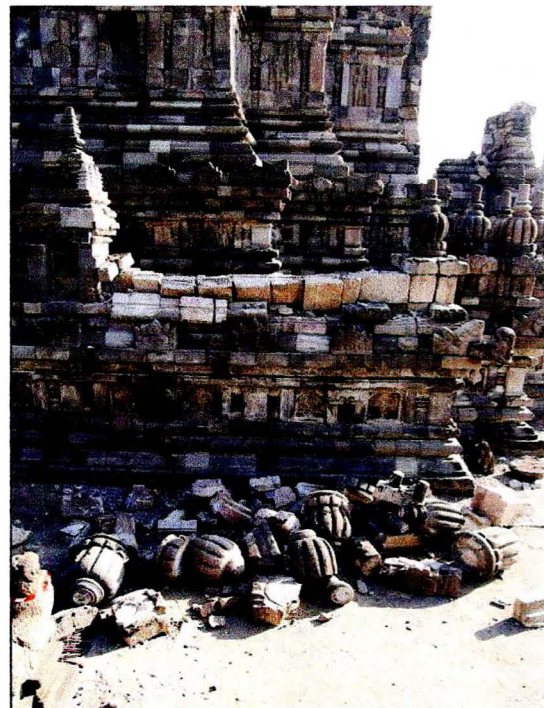
Generally the damage on the stone blocks are: cracks, broken but still in situ, and fragmented. The object of the observation are: the fallen components of the temples, either on the courtyard, on the floor of the balustrade or the still-in-situ stone blocks. It turns out that the heaviest damage on the building material occurs in Brahma temple. There are many components of the roof which fell down and are broken. On Brahma and Wisnu temples many stone blocks are broken, because stoneblocks from the upper stages fell on them. On the other hand the damage on the building material of Siwa temple are mostly cracks on the stone. It seems because the space among the stoneblocks were filled with cement, they became monolithic structure.

Material damage on Brahma and Wisnu temple

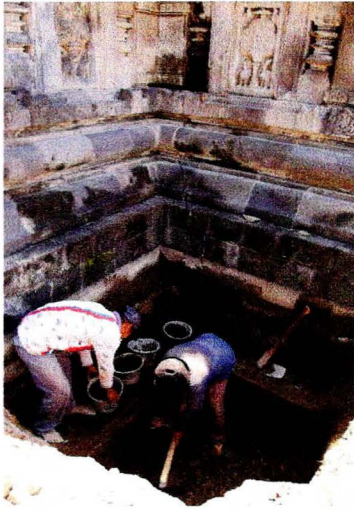
This hole is dig considering the occurrence of the crack on the stone structure which can be observed from the southeast corner to the basement of the temple. The hole measures $2 \times 2 \text{ m}^2$ while the depth of the hole is 240 cm. The north wall of the hole is lime stone structure, the part of the temple basement. The lime stone structure on this level consists of 4 (four) levels. The soil consists of soil which mixes with sand and lime stone gravel. It is assumed that the gravel derives from the basement-making residue.

Excavation on Brahma Temple

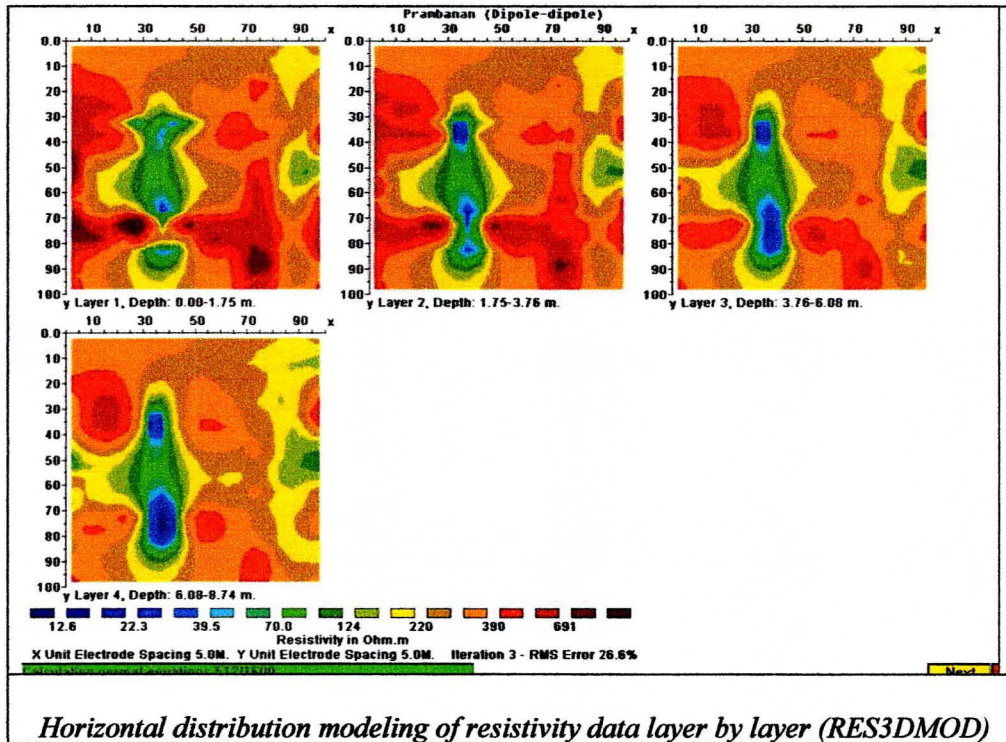
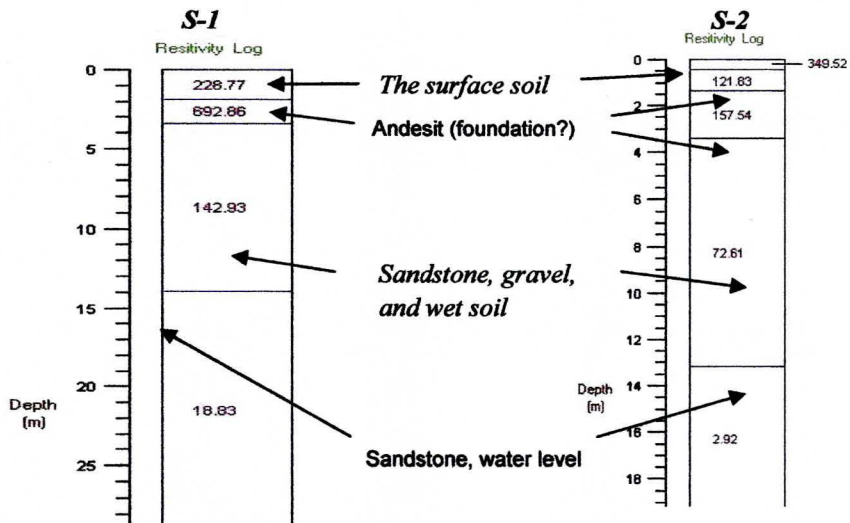
The vertical electrical sounding interpretation of point S1 and S2 are illustrated in Fig 3. S1 is located in east side of Siwa and S2 is located in west side of Nandi. Based on the model, thick of the surface soil is less than 2 m, and there is about 2 m thick of high resistivity layer (ohm-m) at Siwa floor. We interpret it as an andesitis rock or a foundation rock. However, in S2 the resistivity is not so high, and lower than this layer is low resistivity area, it may be a wet sandstone, wet soil, and gravel as a water level. According to Ijzerman in Jordaan, 1996 in a depth of 5.75 m under the floor, there was a container 41 cm long and wide and 53 cm deep. The top of lid, which is made of soft marlstone, is diamond-shape and coping of soft, light-yellow sandstone fits into the container. The foundation consists of three layers of stone, which together achieve a thickness of 1.15 m, on digging further, round river stones in sand were discovered and at 15.90 m, water.

Vertical electrical sounding interpretation of points S1 and S2 by Progress 3.0.

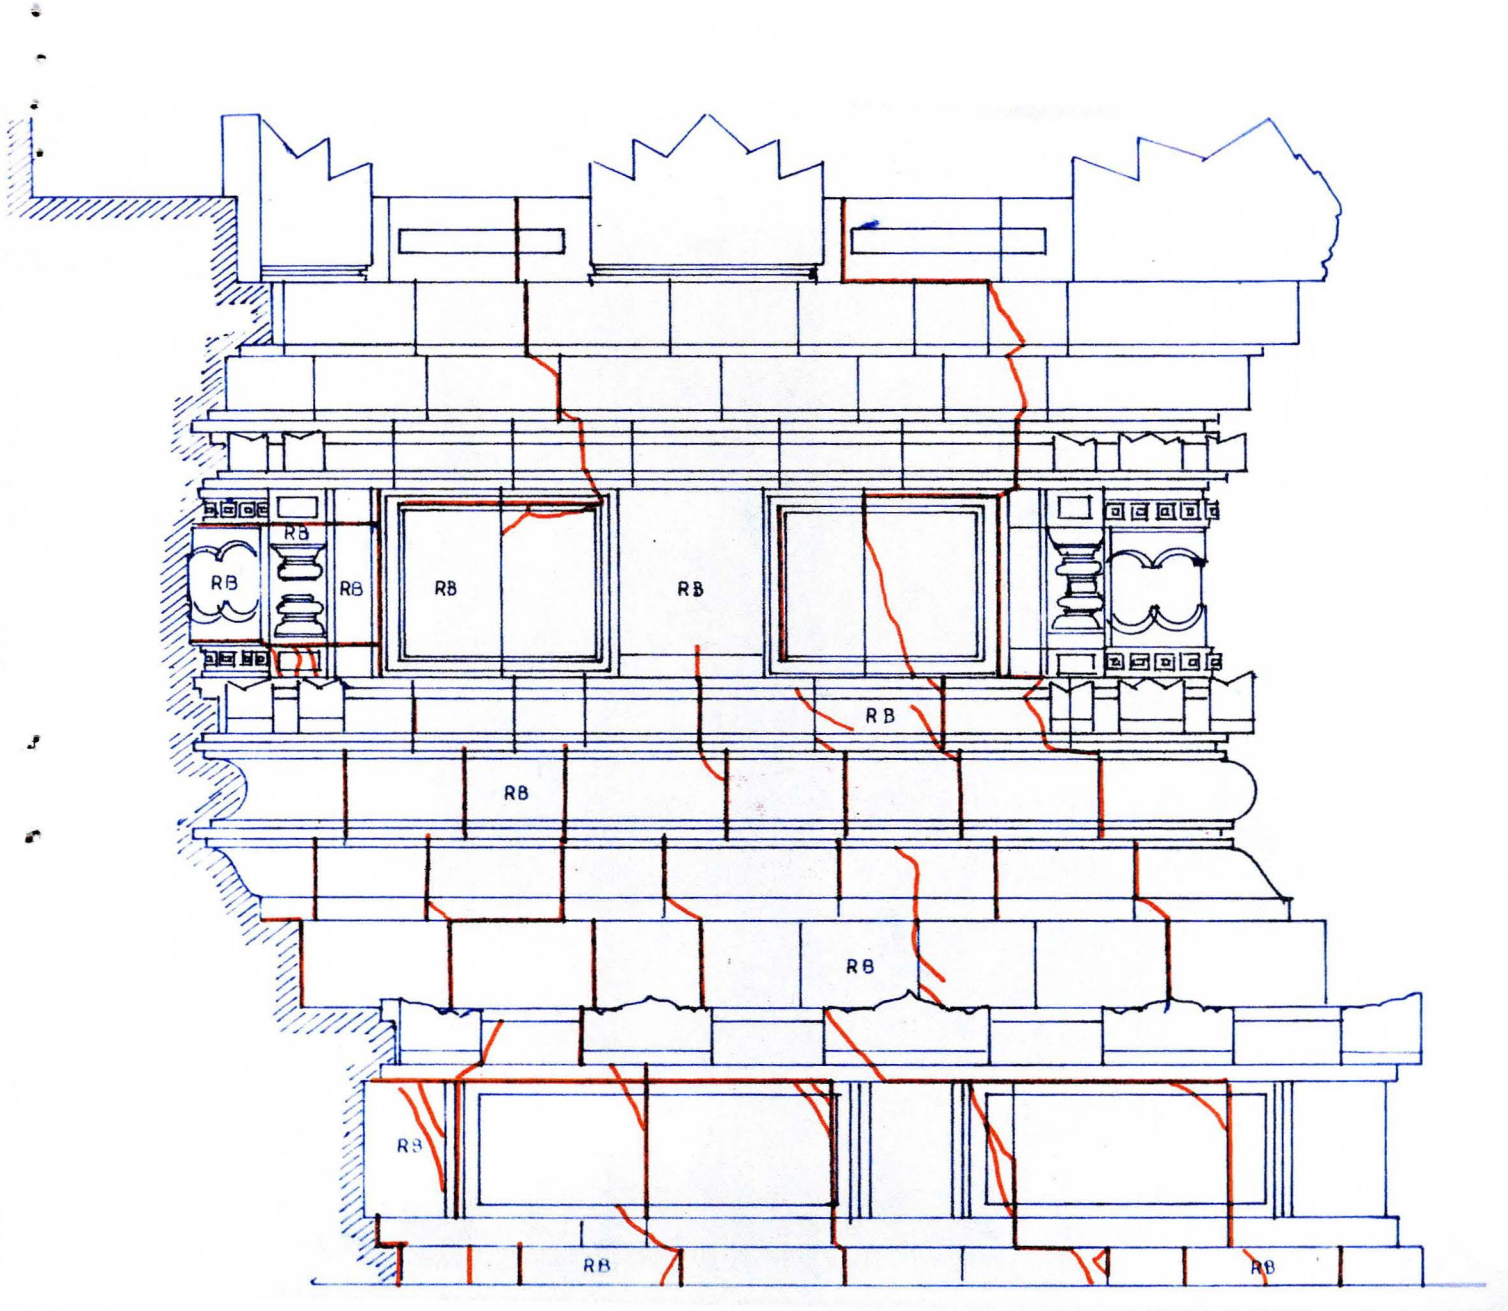
Area II

— Cracking and open joint stone

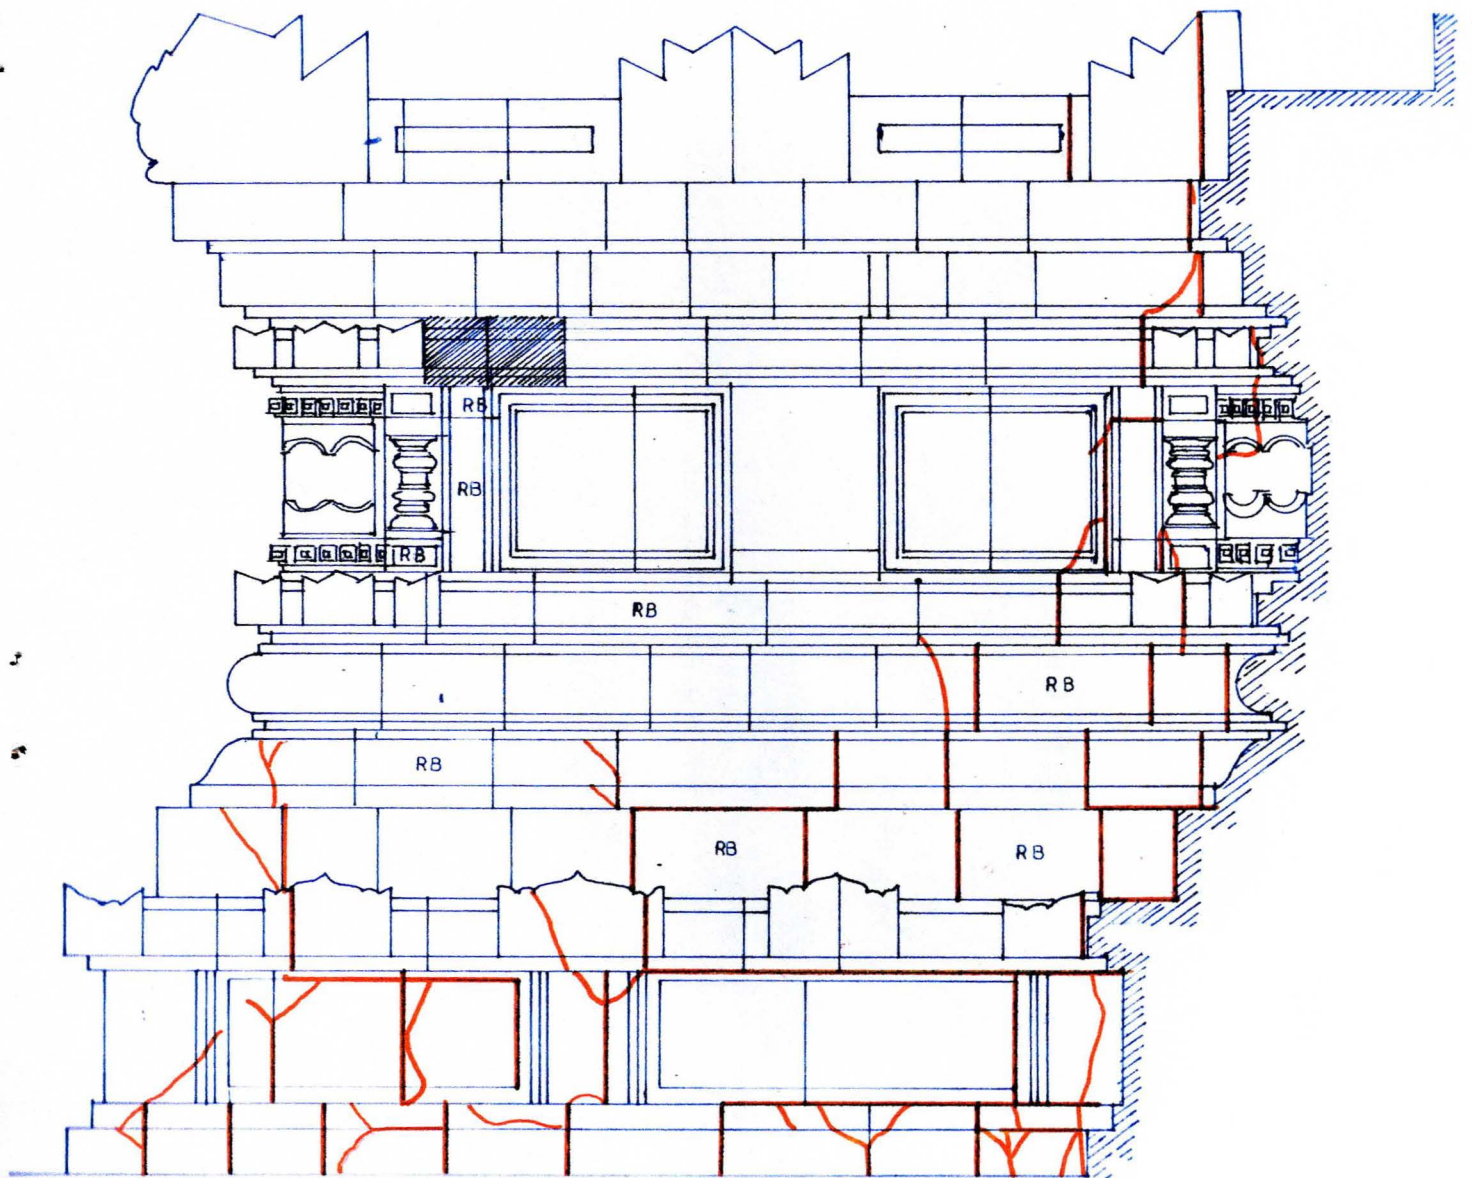
Area 3

— Cracking and open joint stone

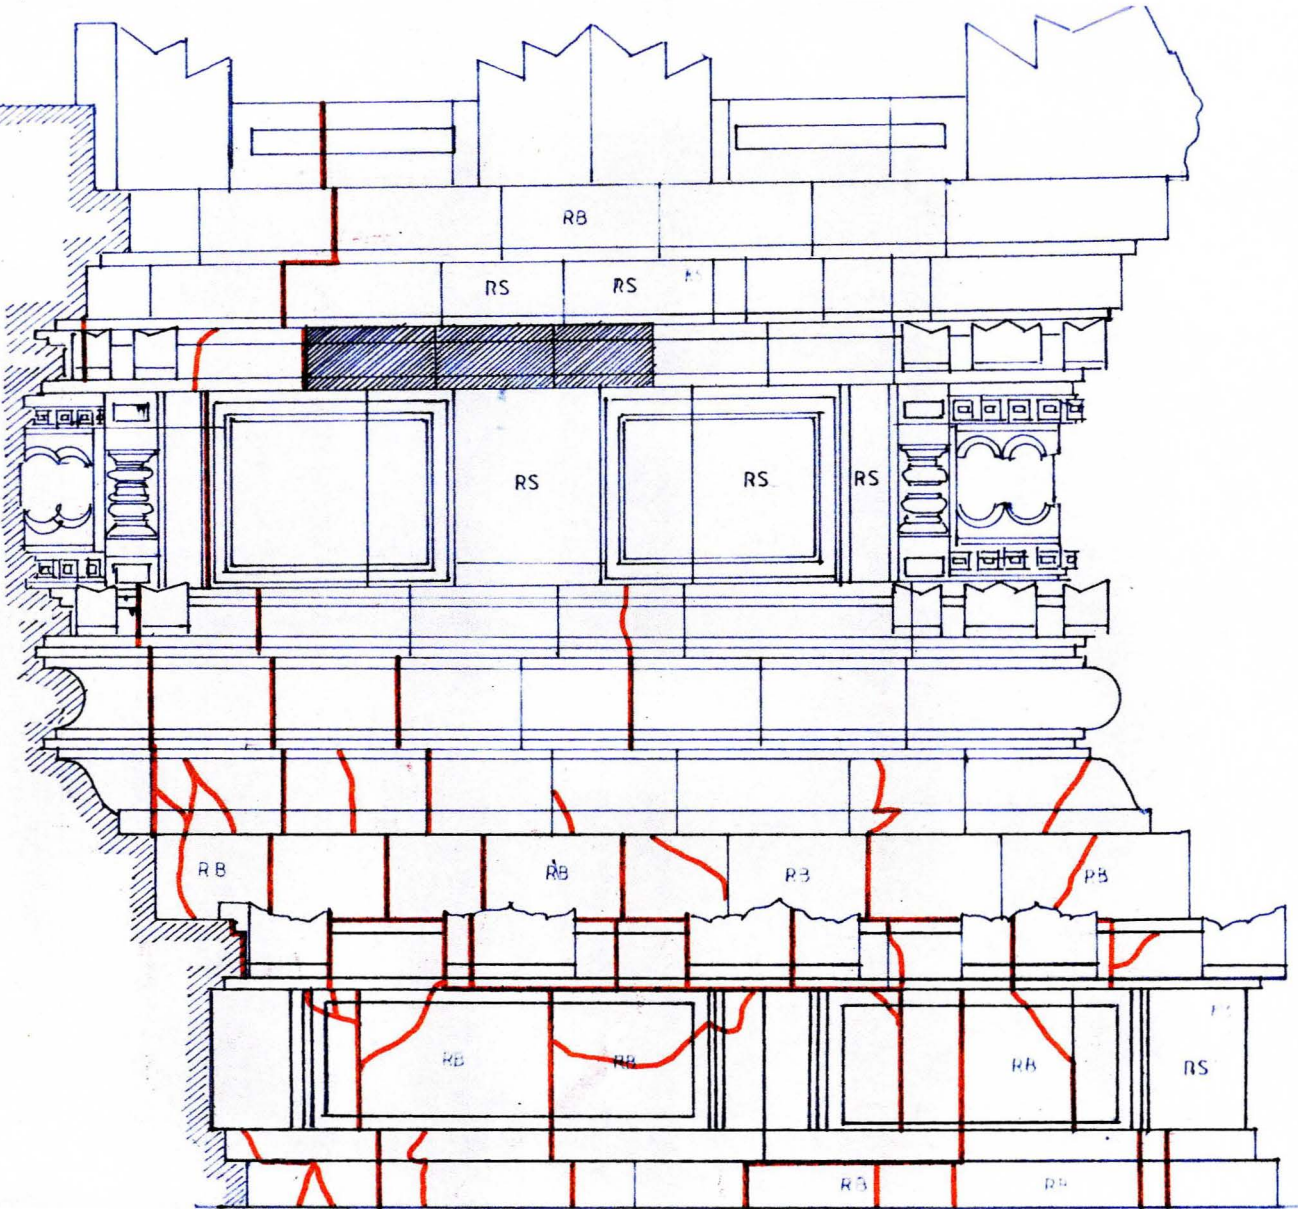
Area 4

— Cracking and open joint stone

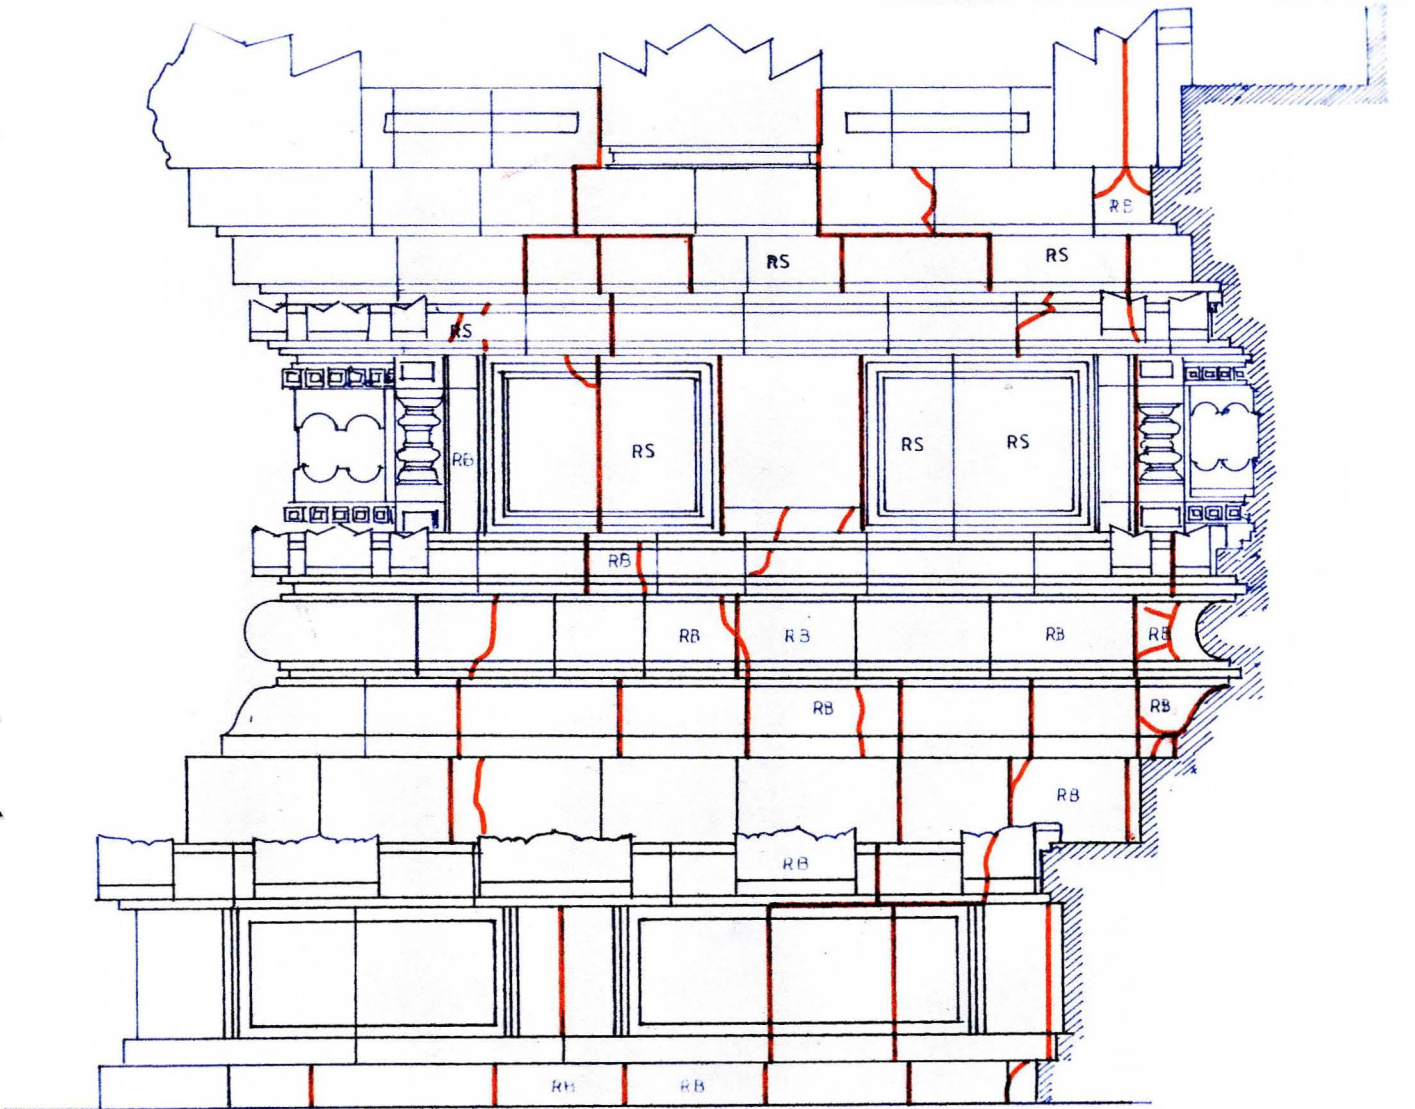
Area 5

— Cracking and open joint stone

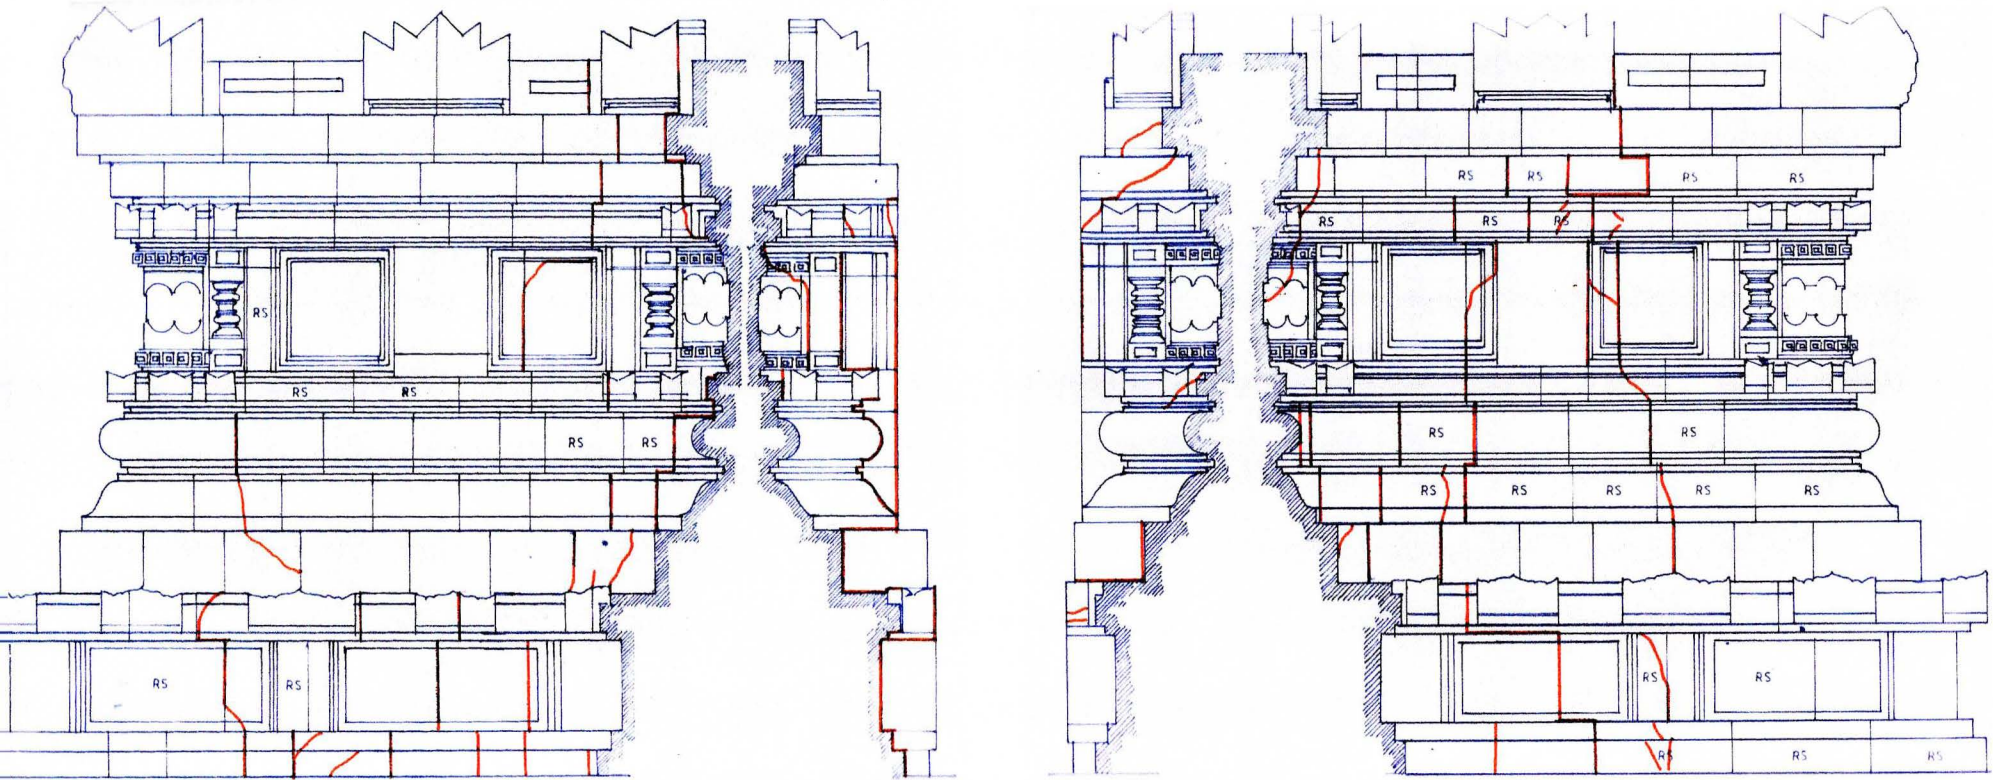
Area 6

— Cracking and open joint stone

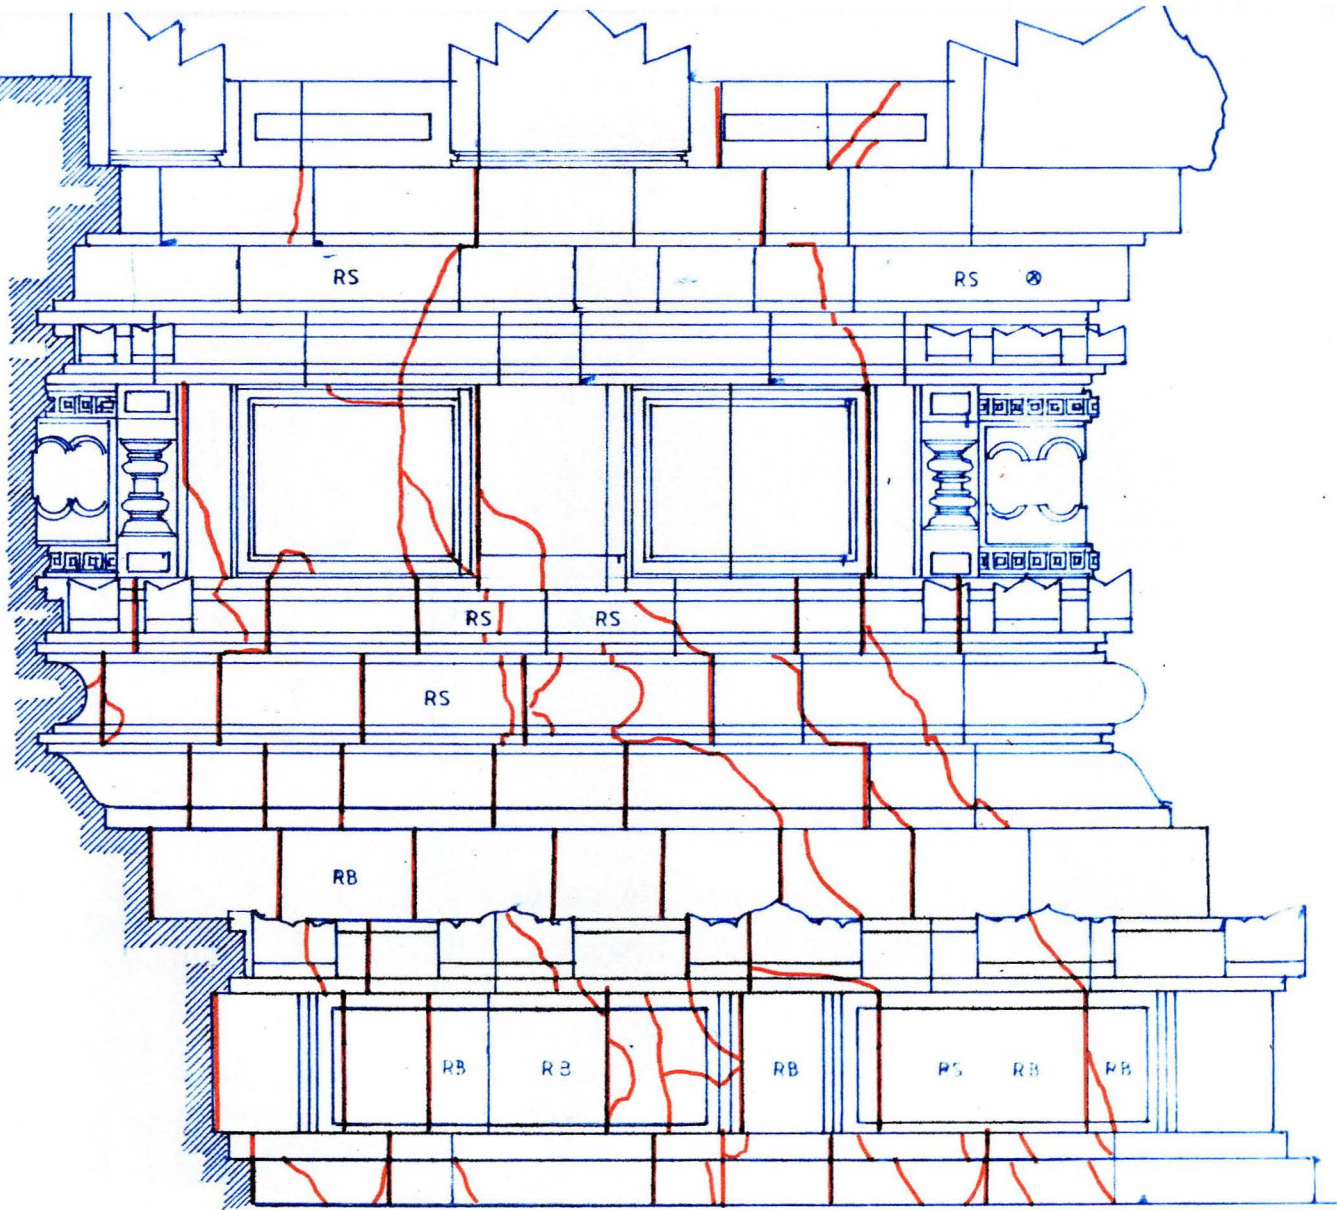
Area 7

— Cracking and open joint stone

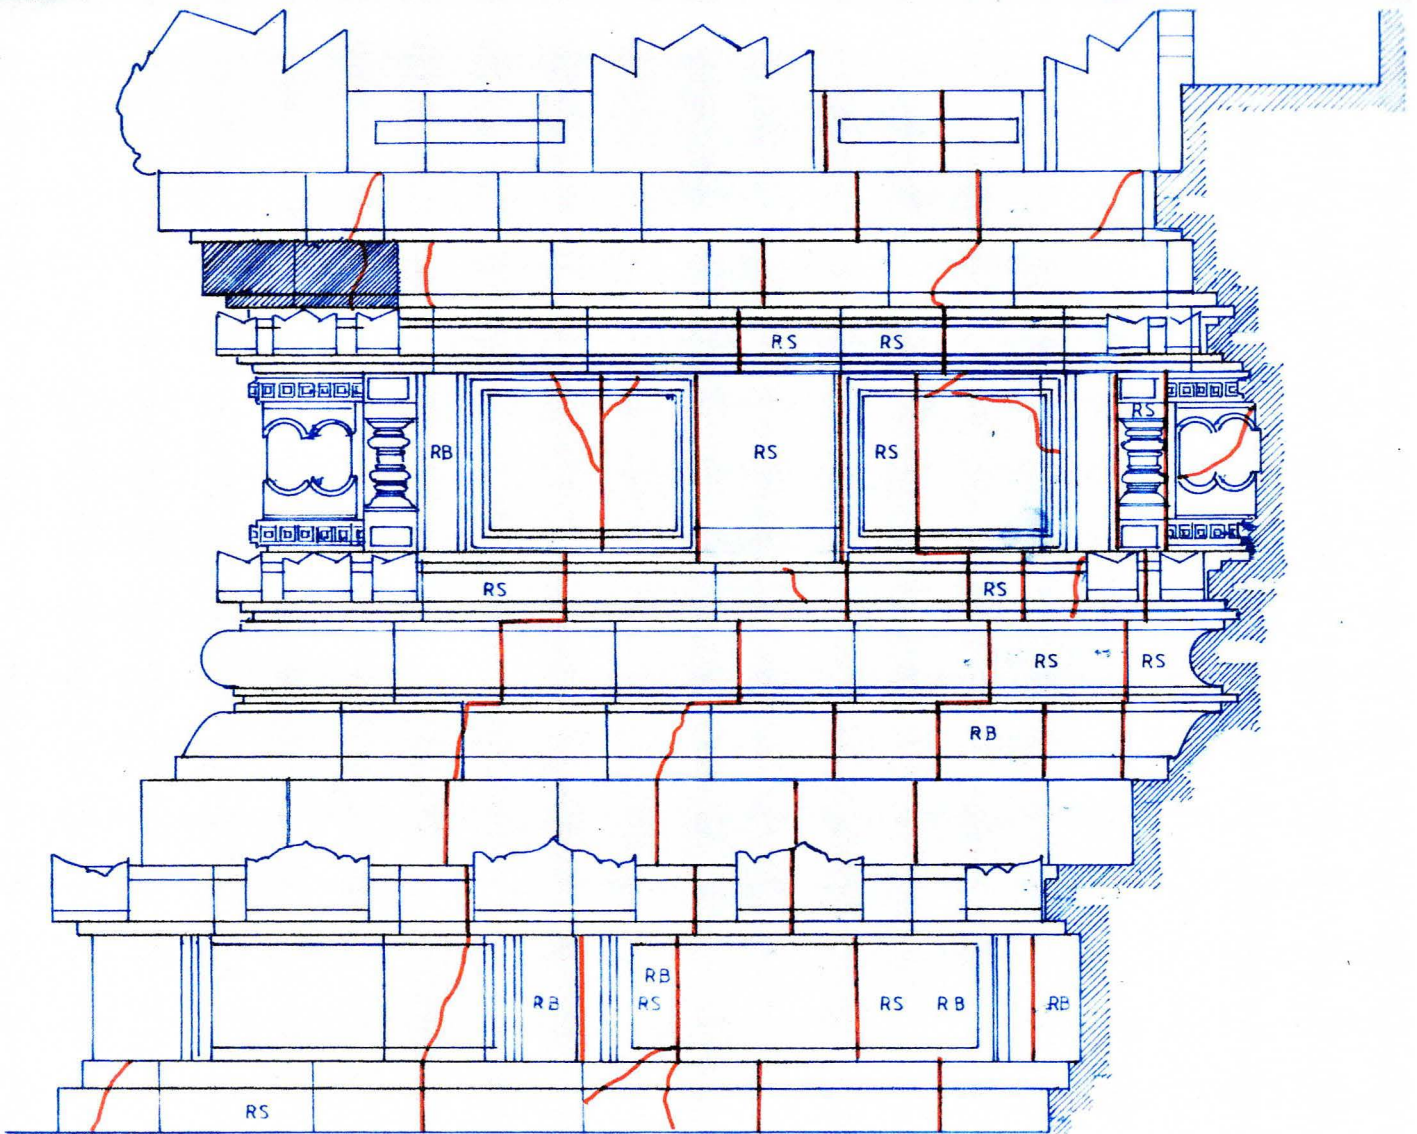
Area 8

— Craking and open joint stone

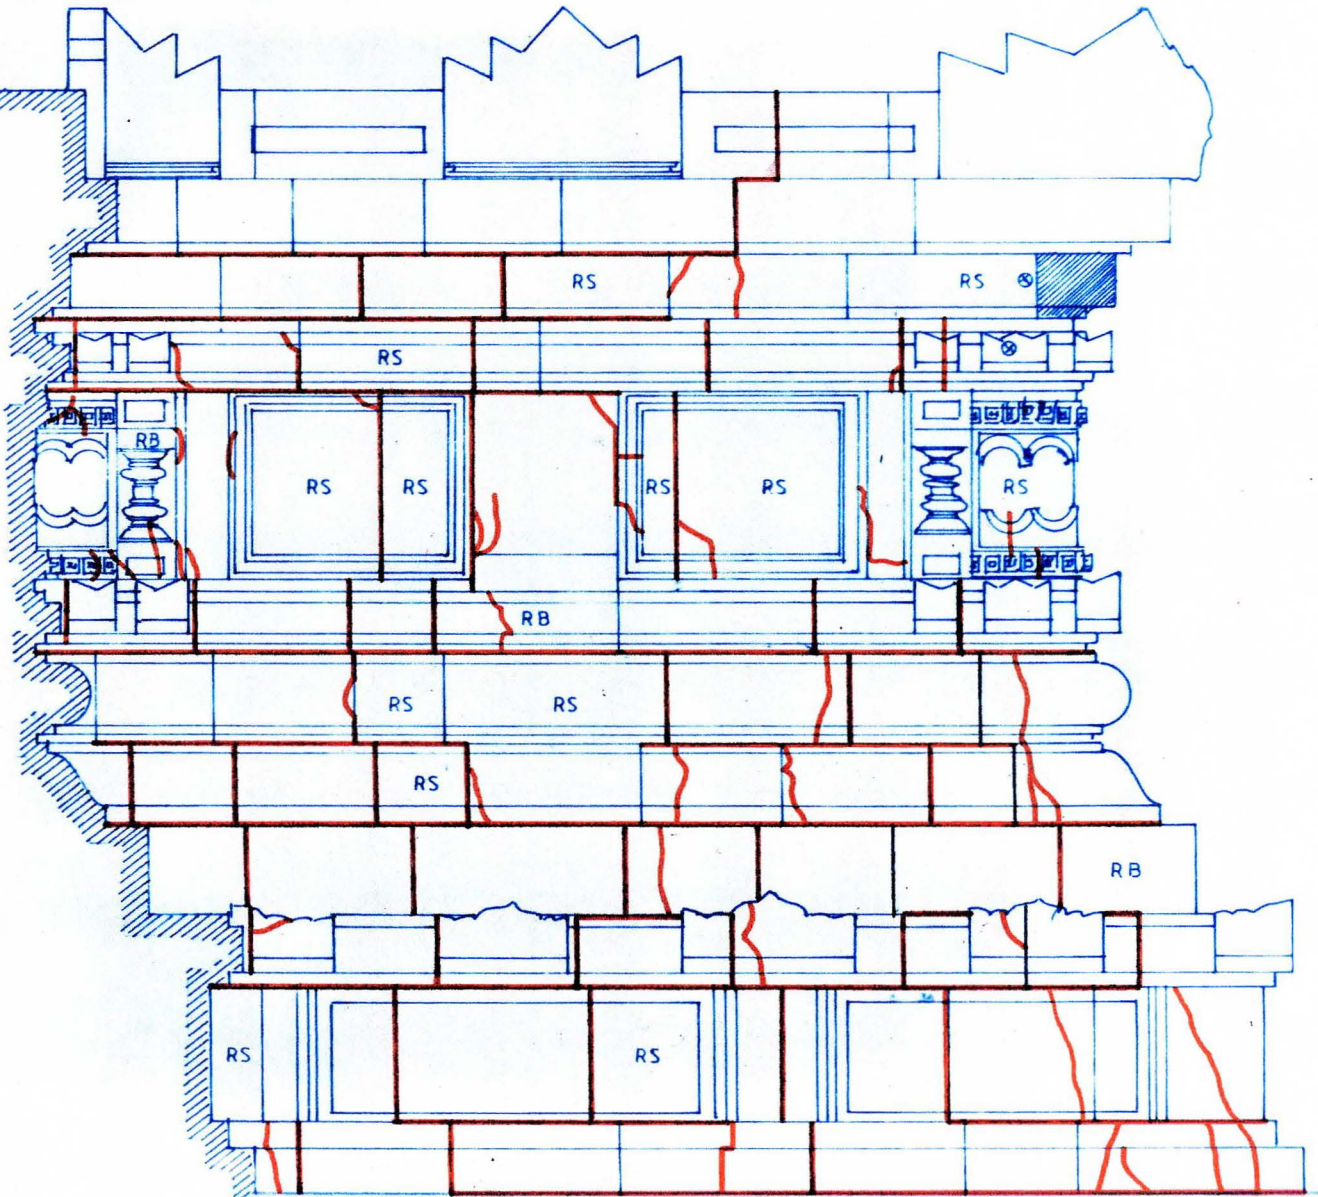
Area 9

— Craking and open joint stone

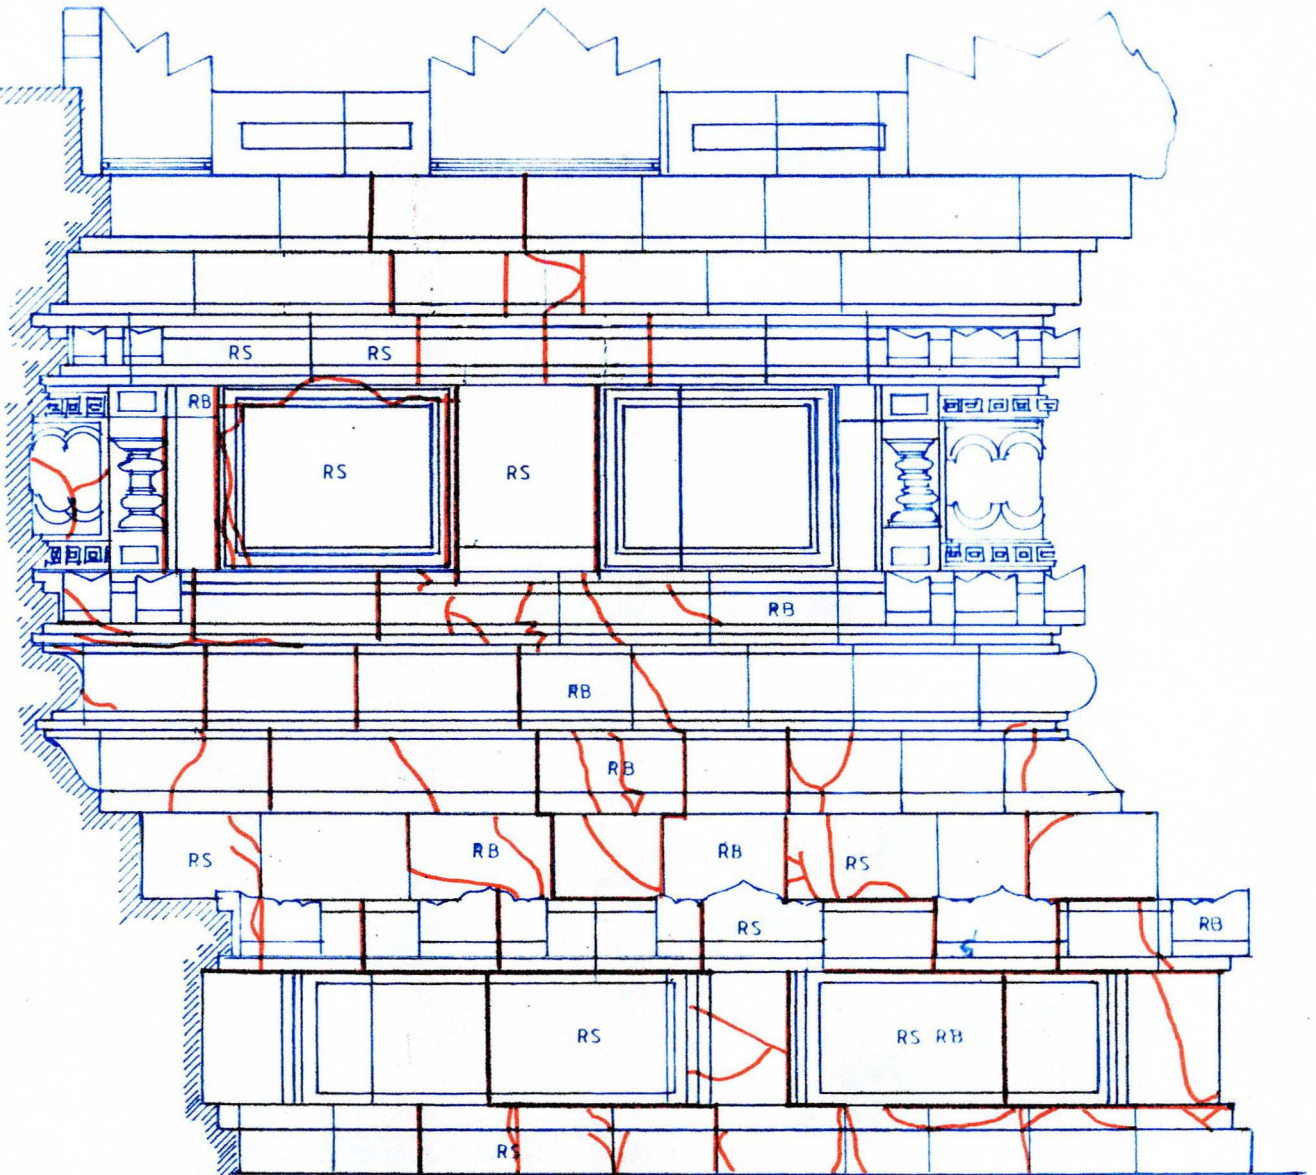
Area 12

— Cracking and open joint stone

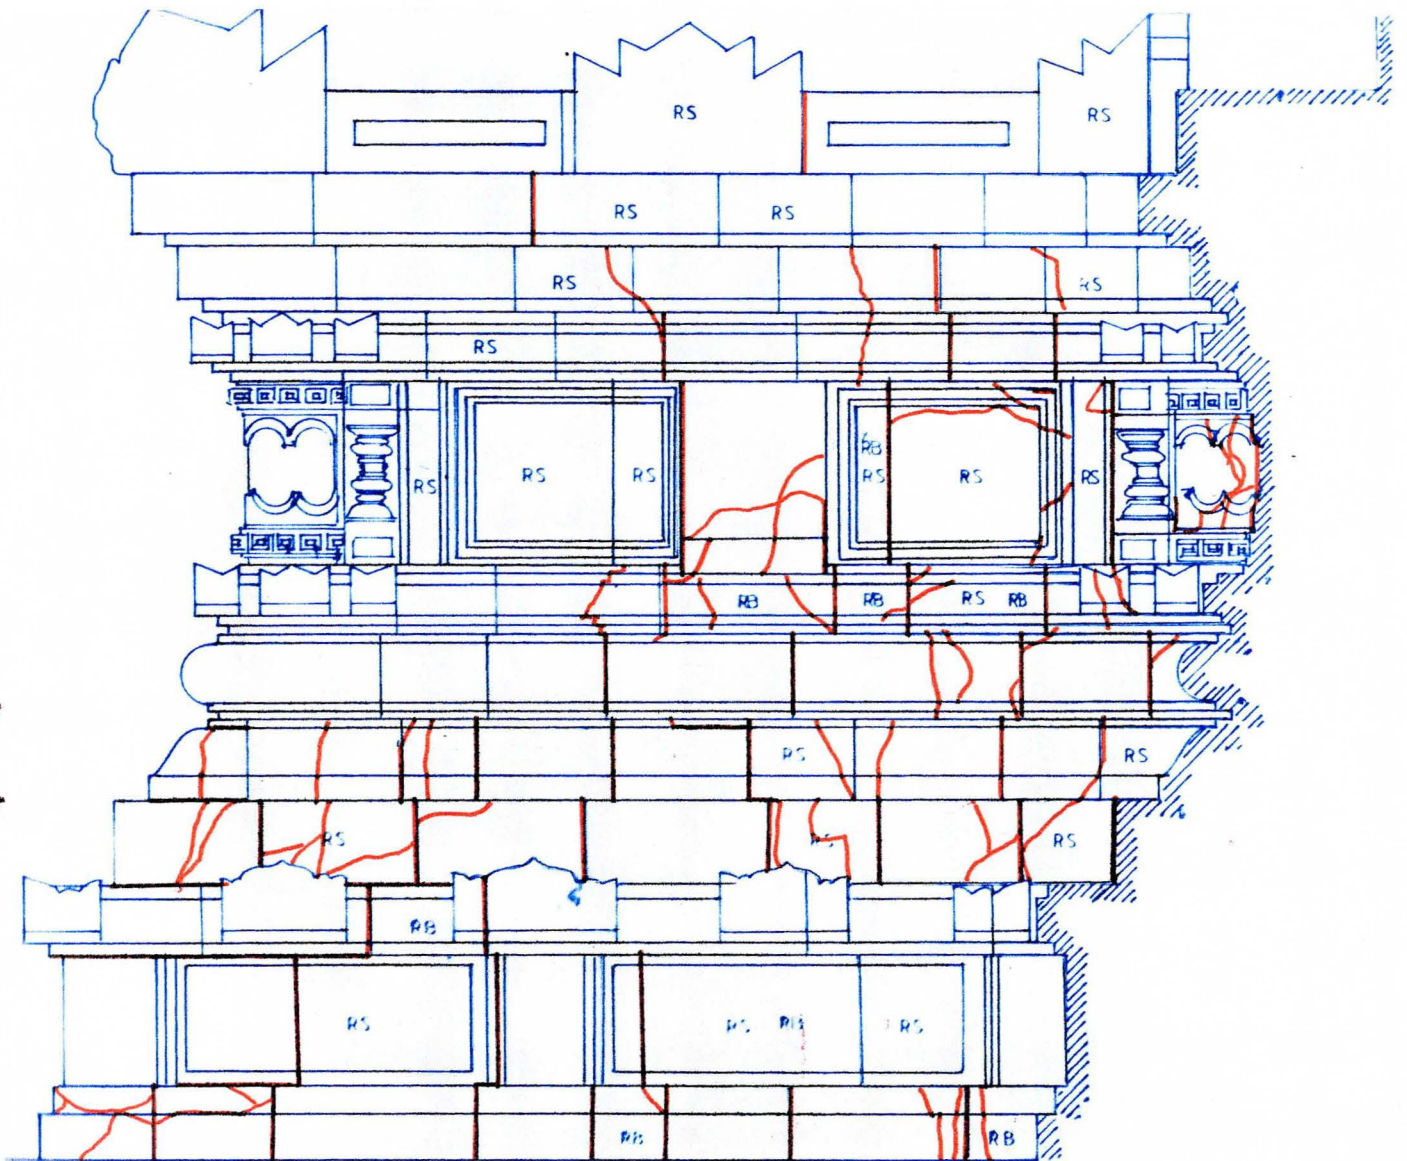
Area 13

— Cracking and open joint stone

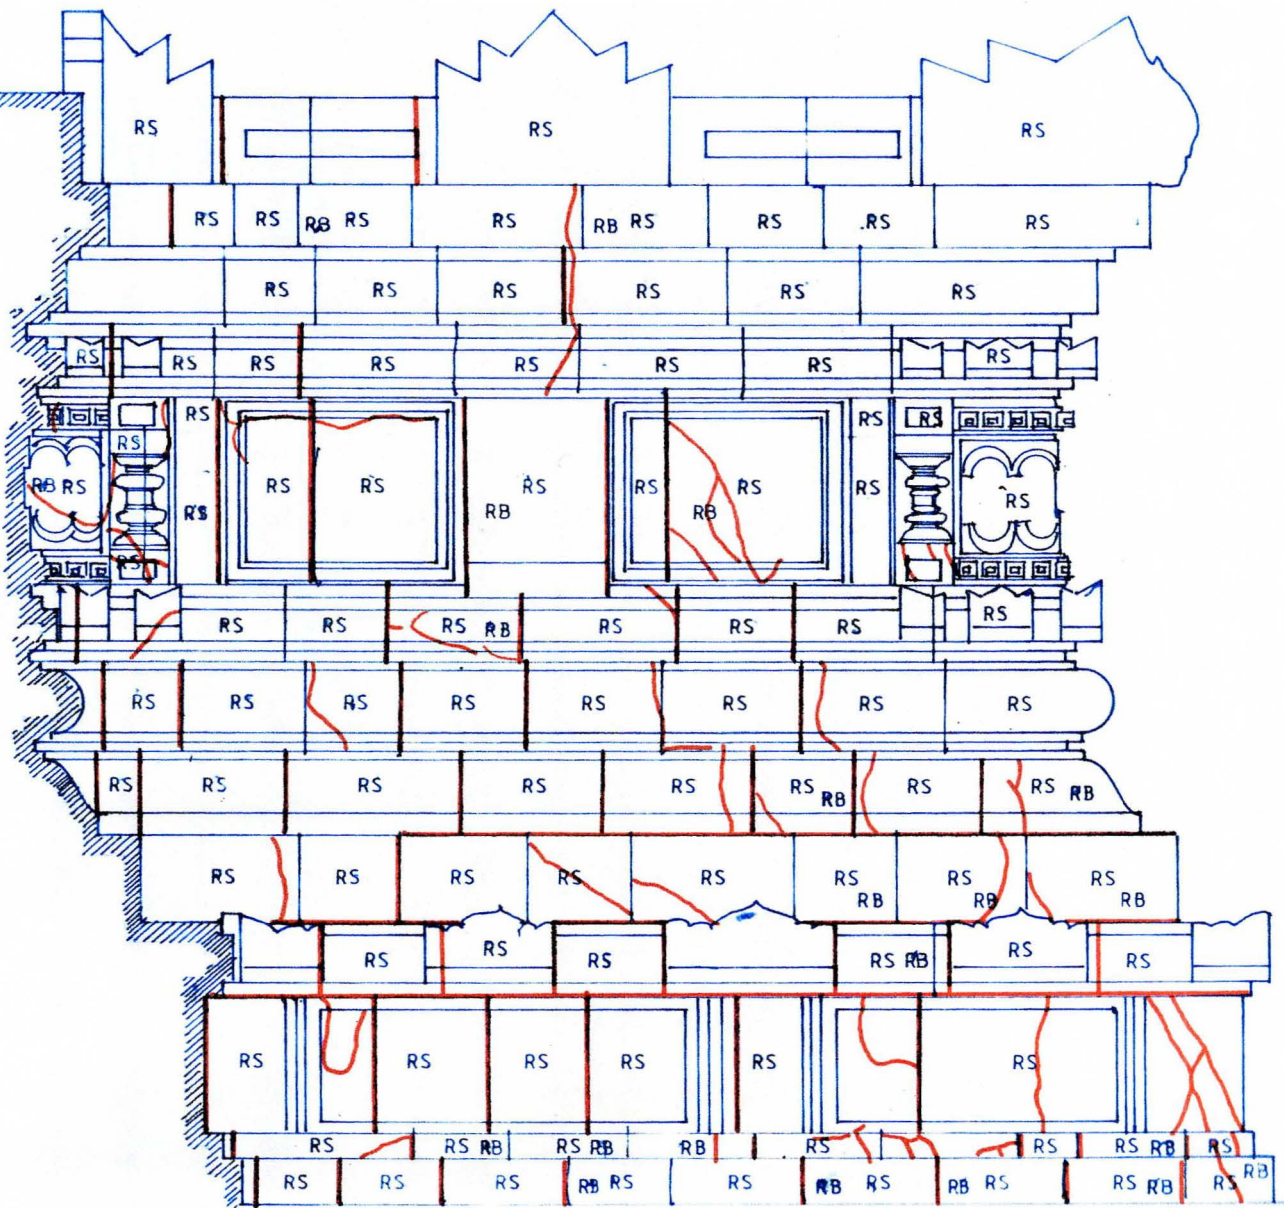
Area 14

— Cracking and open joint stone
