TECHNICAL STUDY
FOR REHABILITATION
ON PRAMBANAN TEMPLE COMPOUND
AFTER EARTHQUAKE

BY
TECHNICAL STUDY TEAM
ARCHAEOLOGICAL OFFICE OF YOGYAKARTA

DEPARTMENT OF CULTURE AND TOURISM
2007

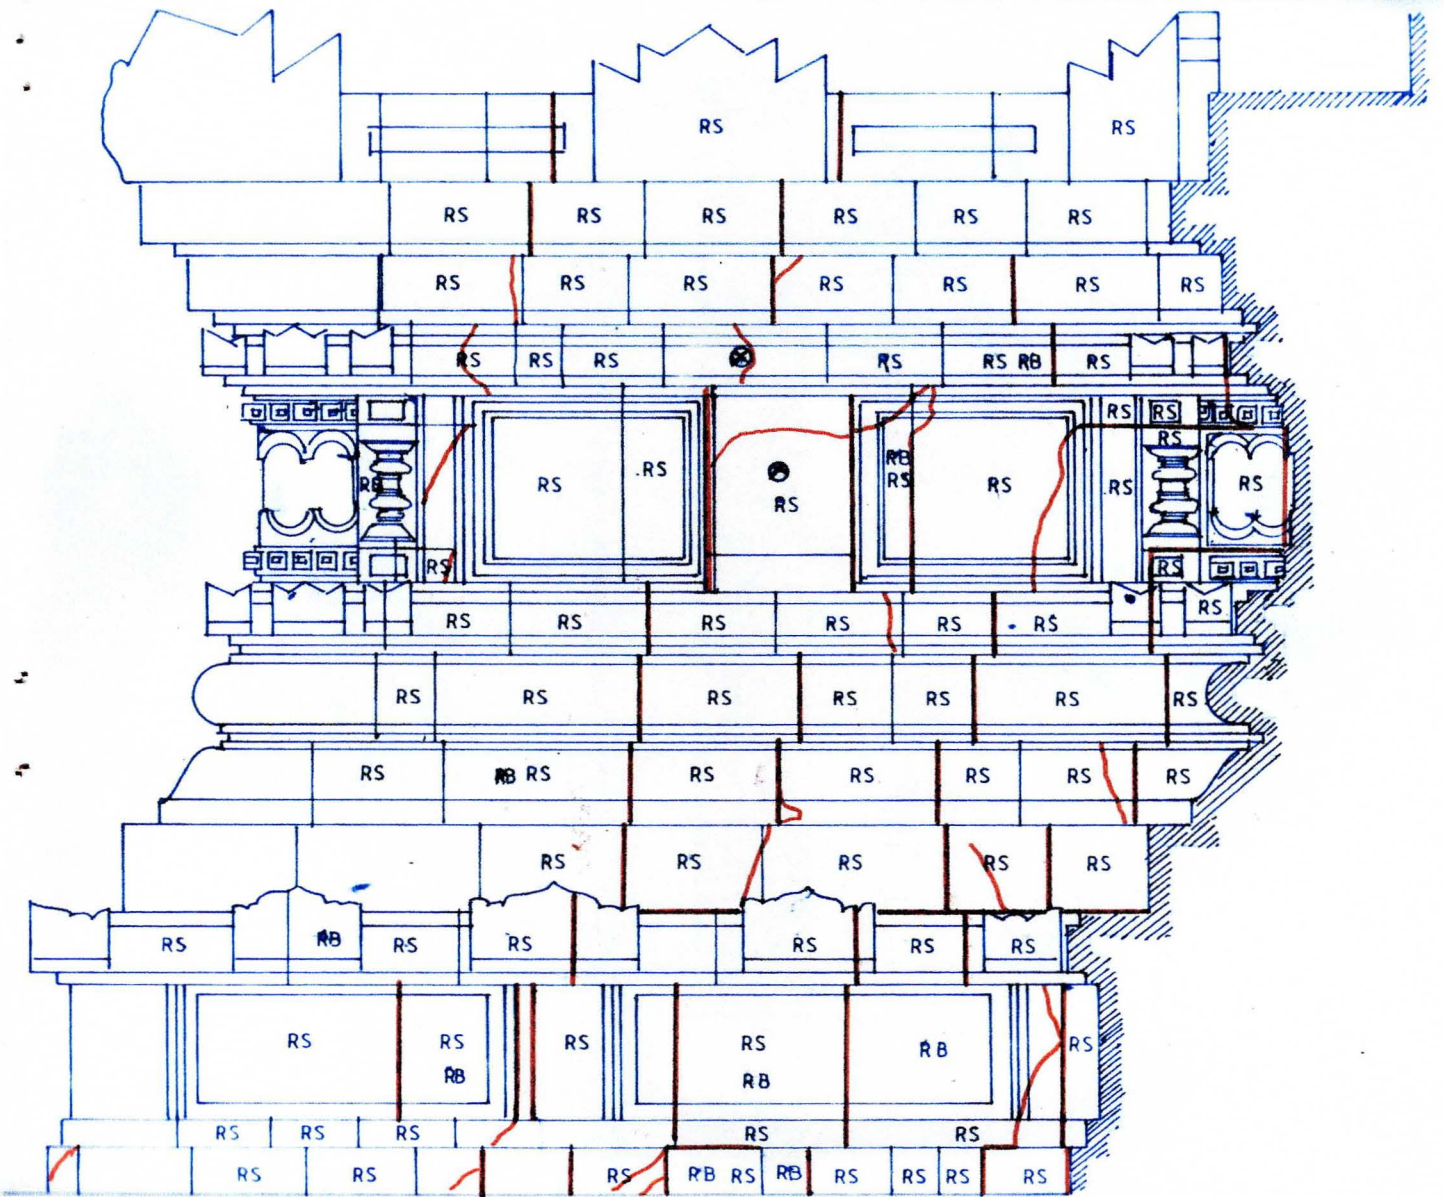
Area 15

— Craking and open joint

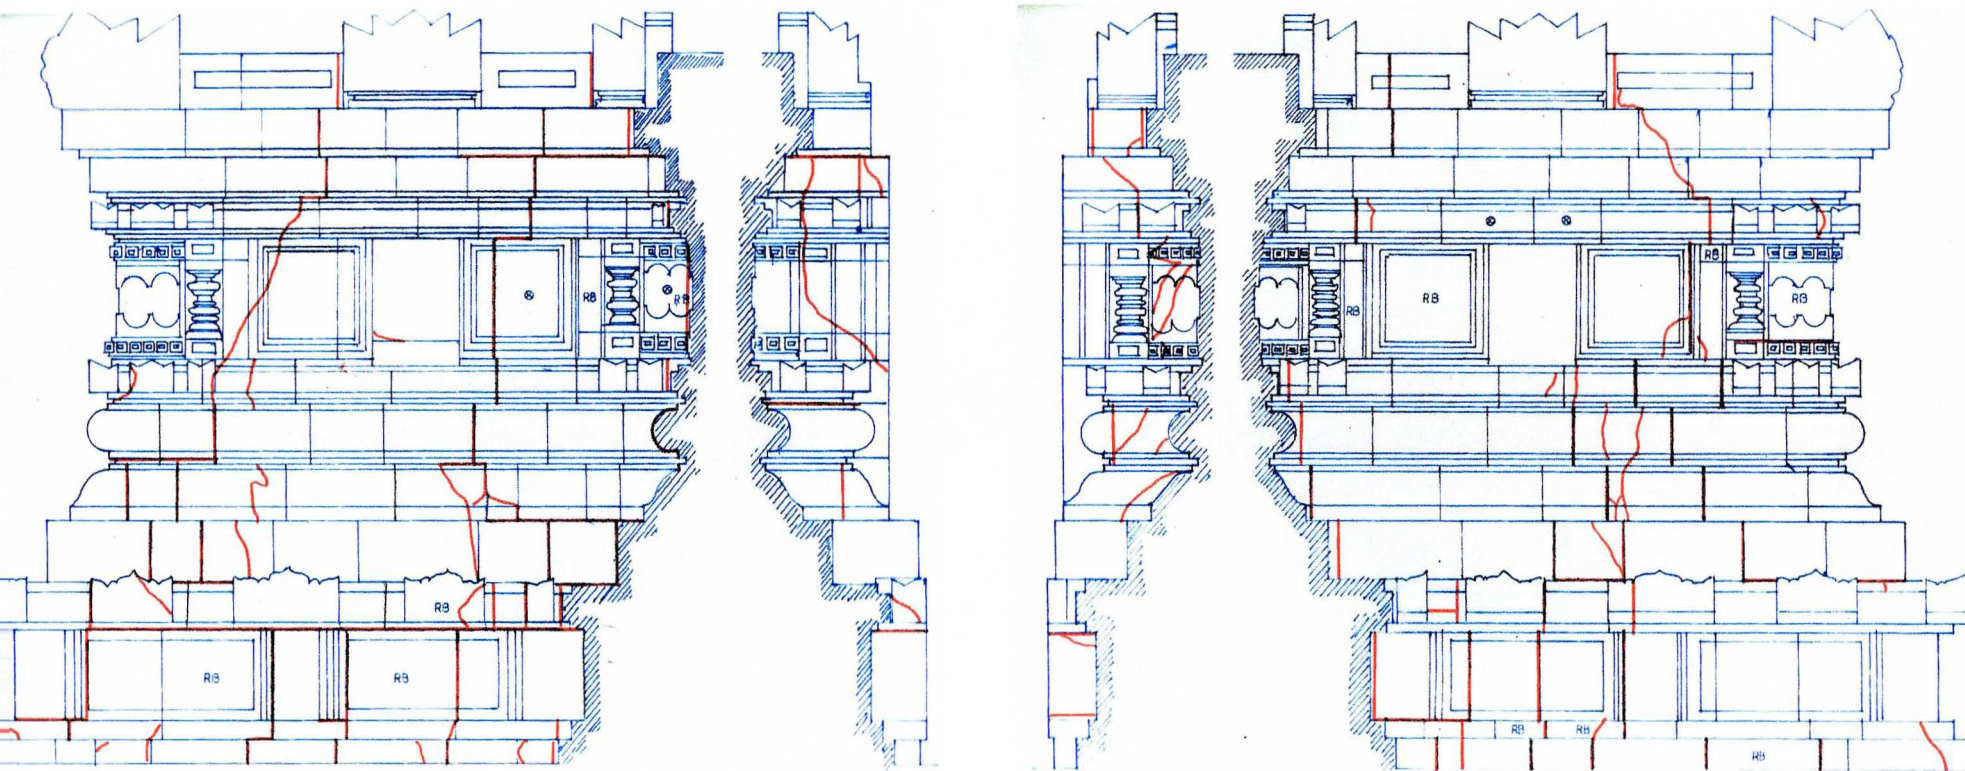
Area XVI

— Cracking and open joint stone

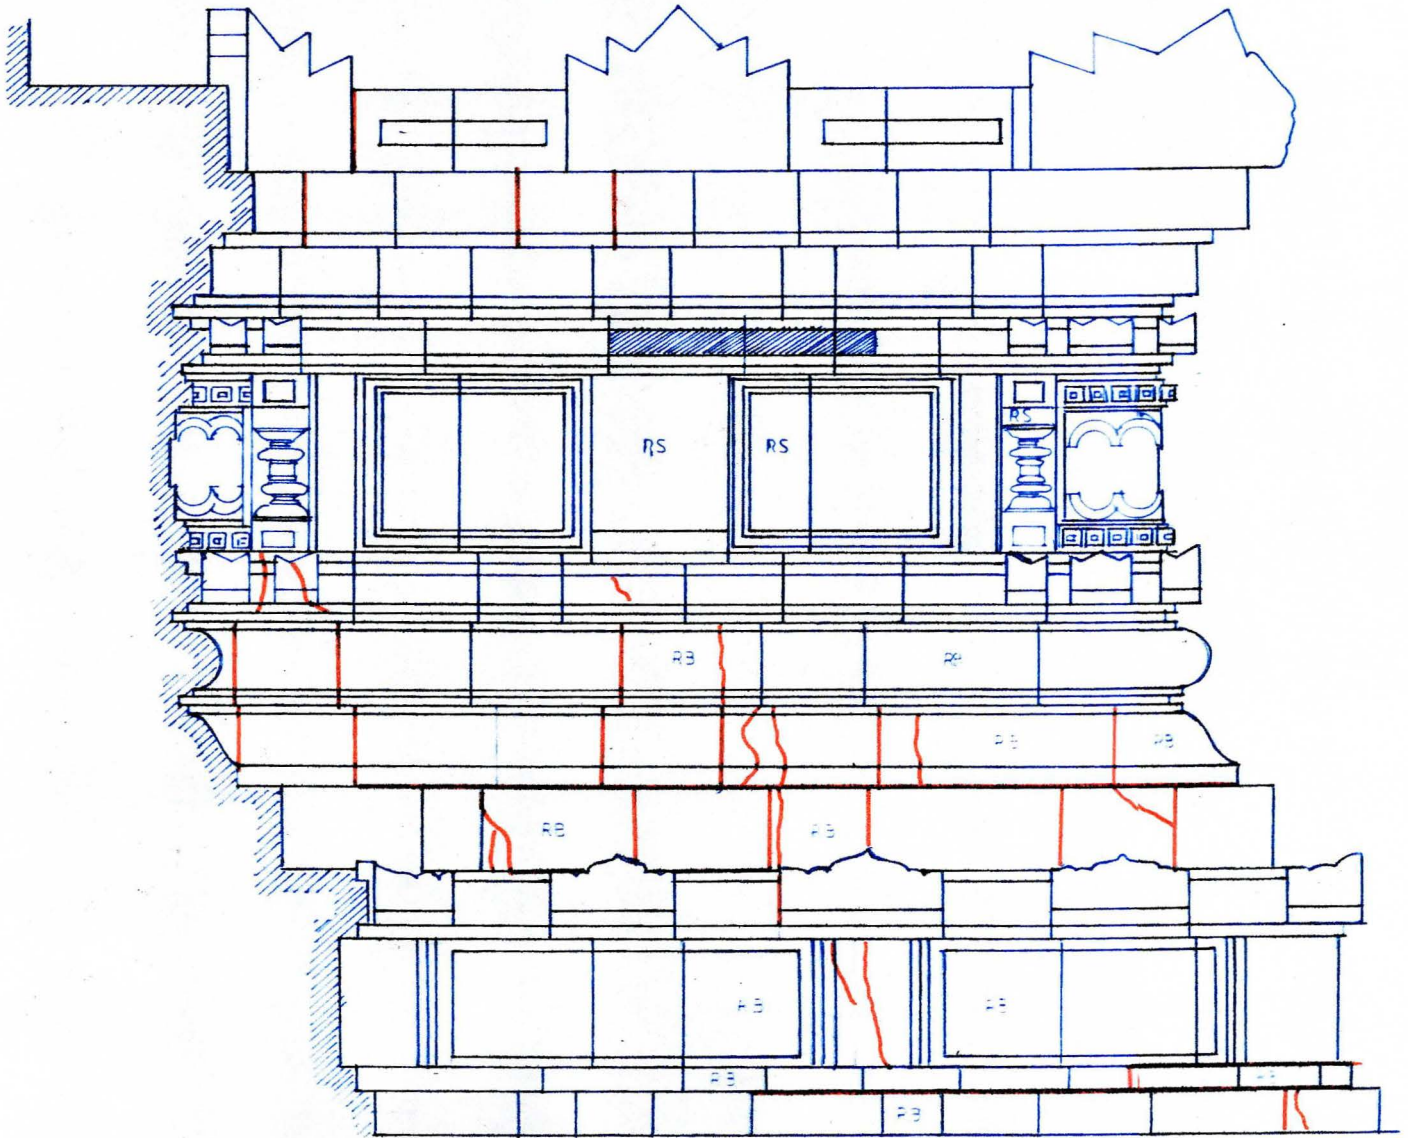
Area 17

— Craking and open joint stone

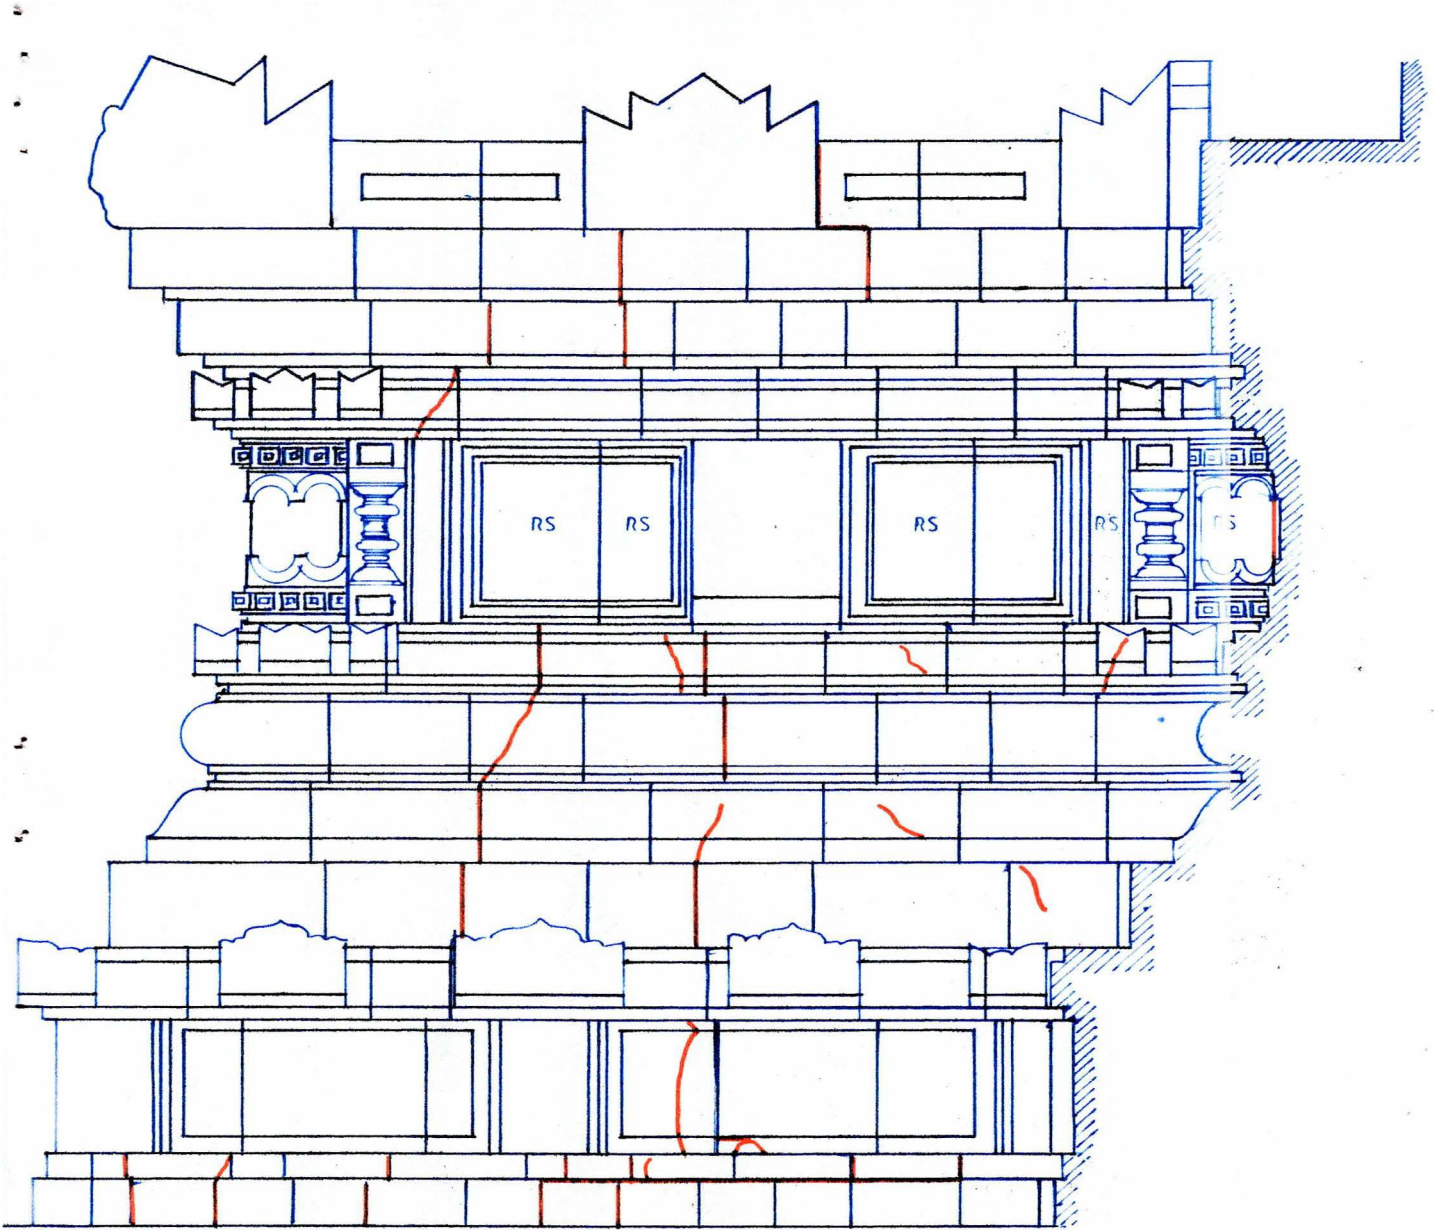
Area18

— Craking and open joint stone

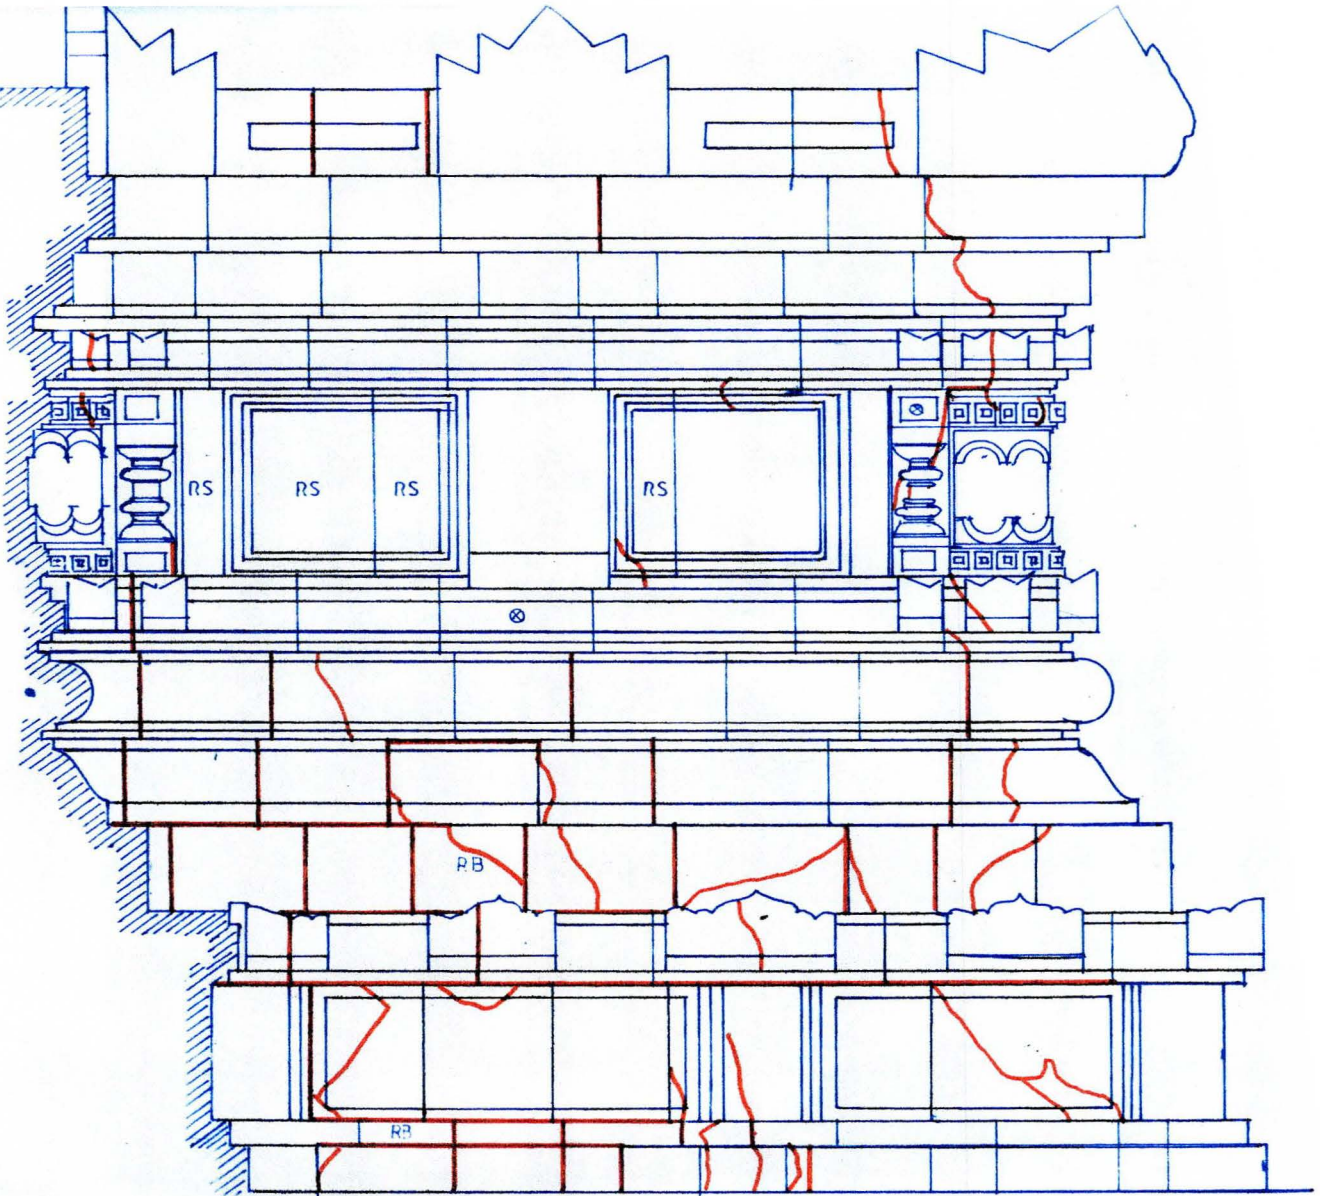
Area 19

— Craking and open joint stone

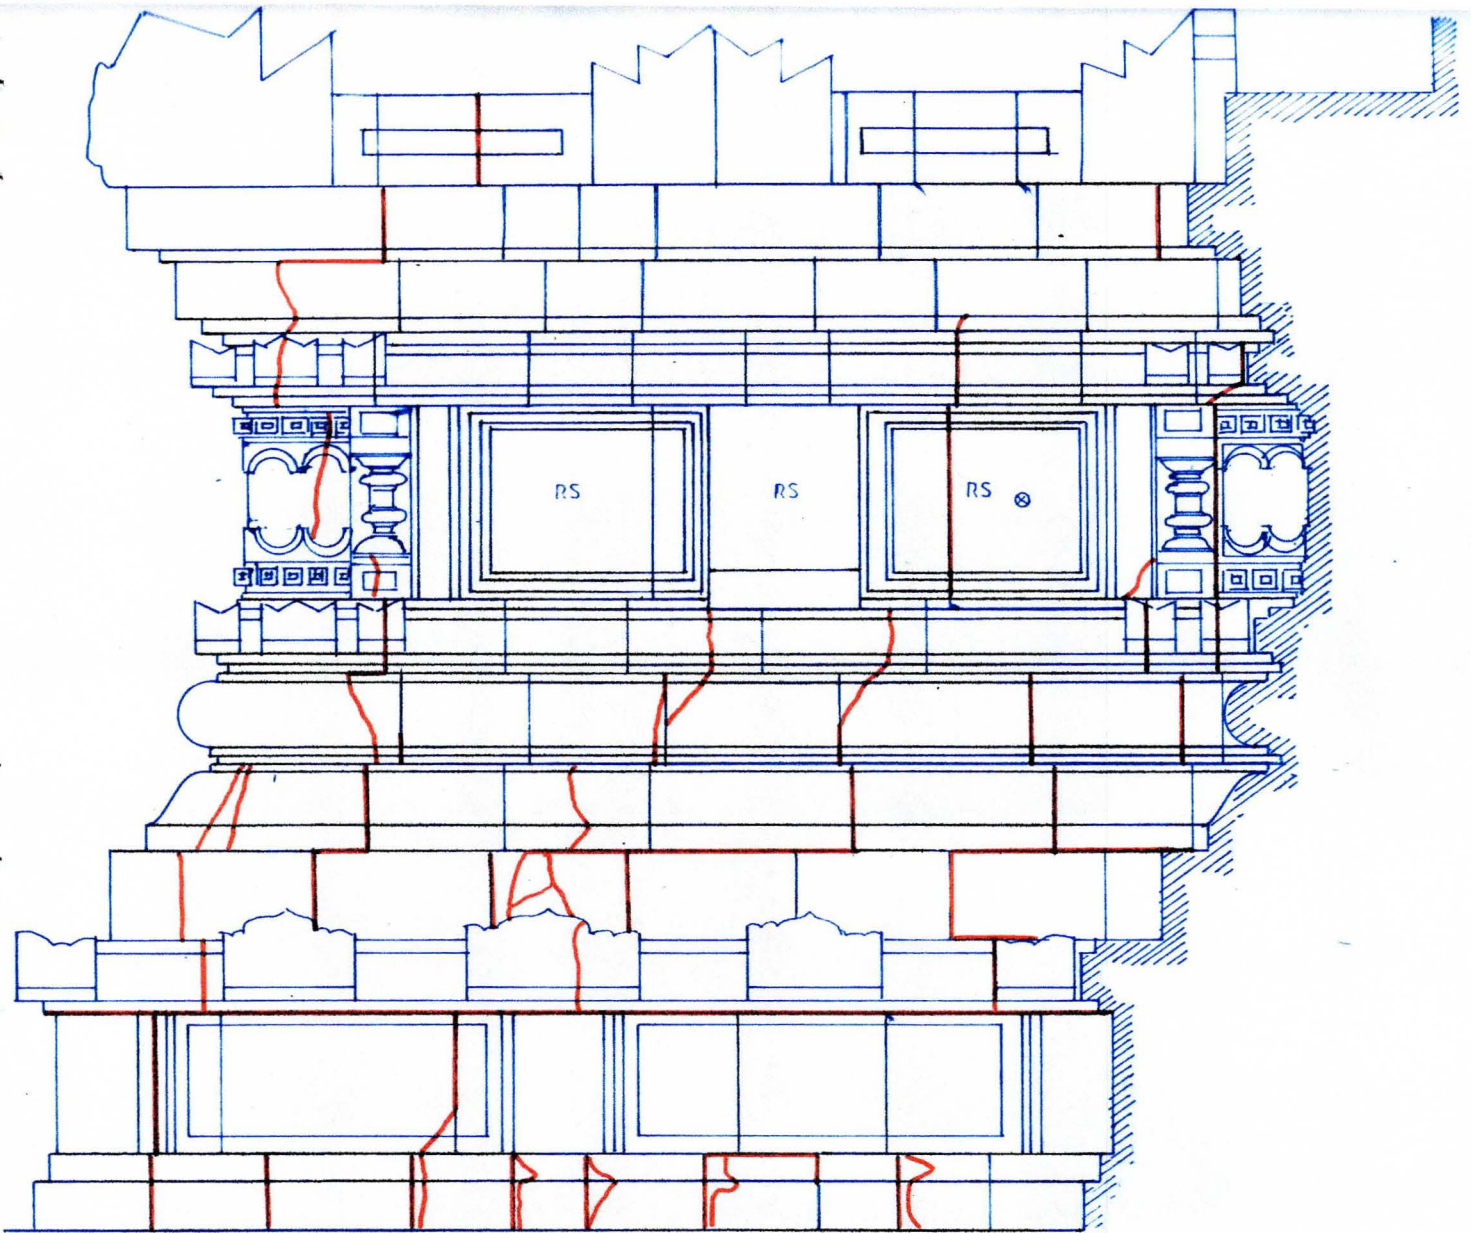
Area 20

— Cracking and open joint stone

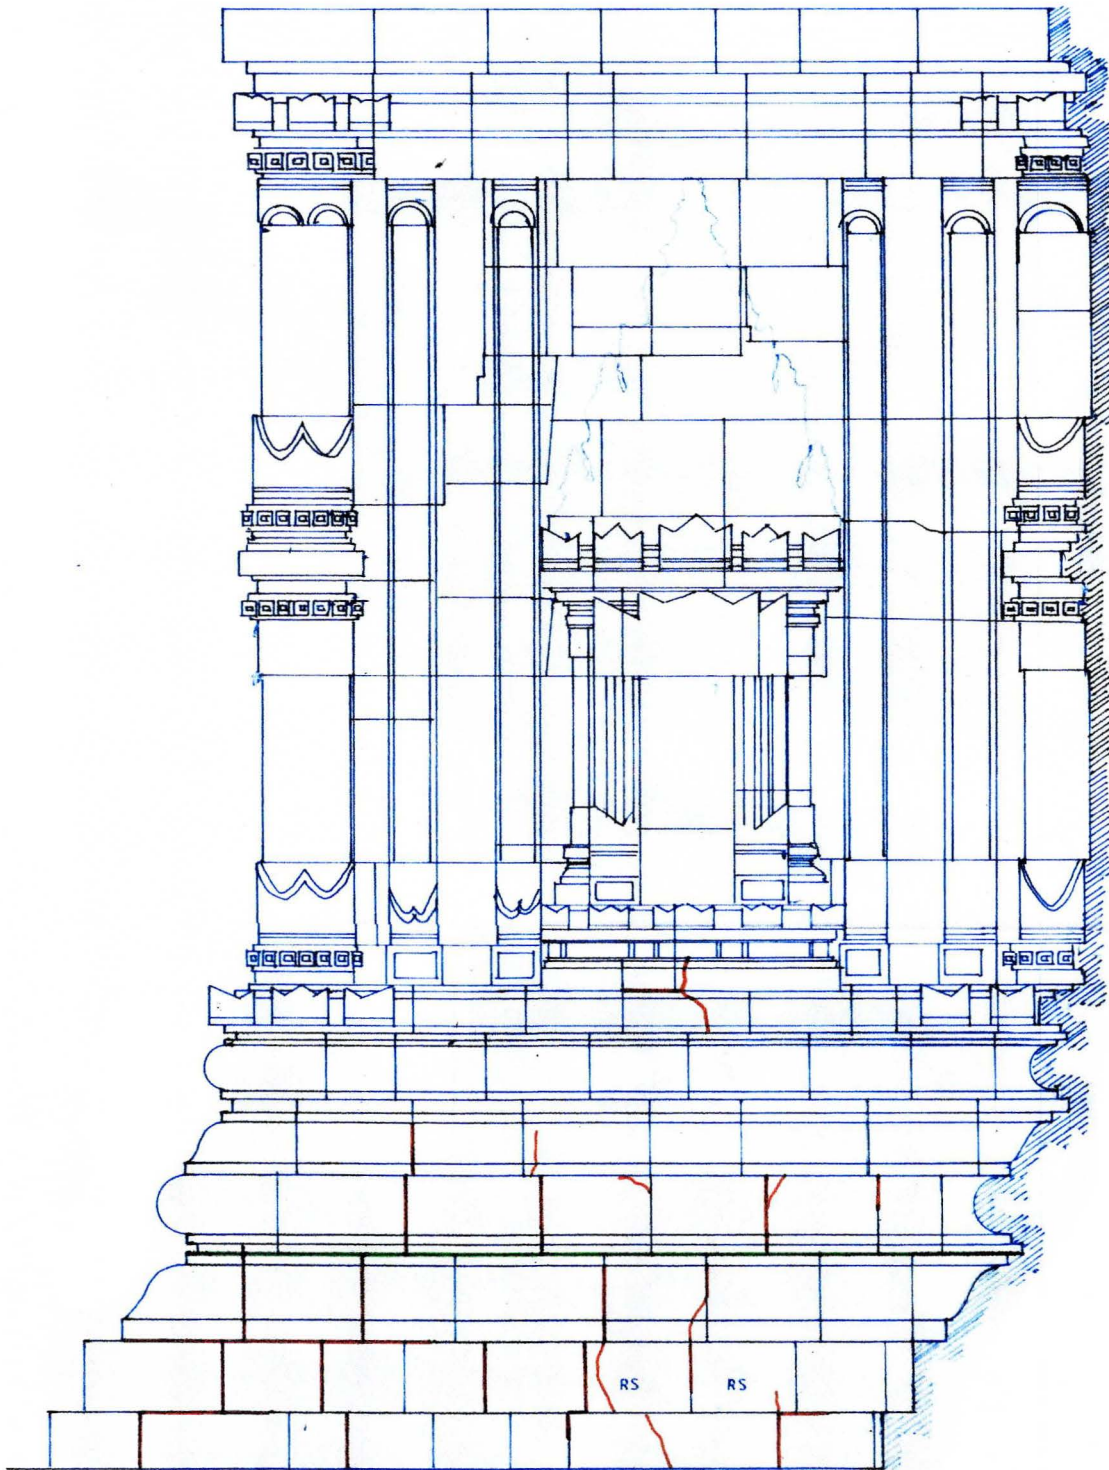
Area III

— Craking and open joint stone

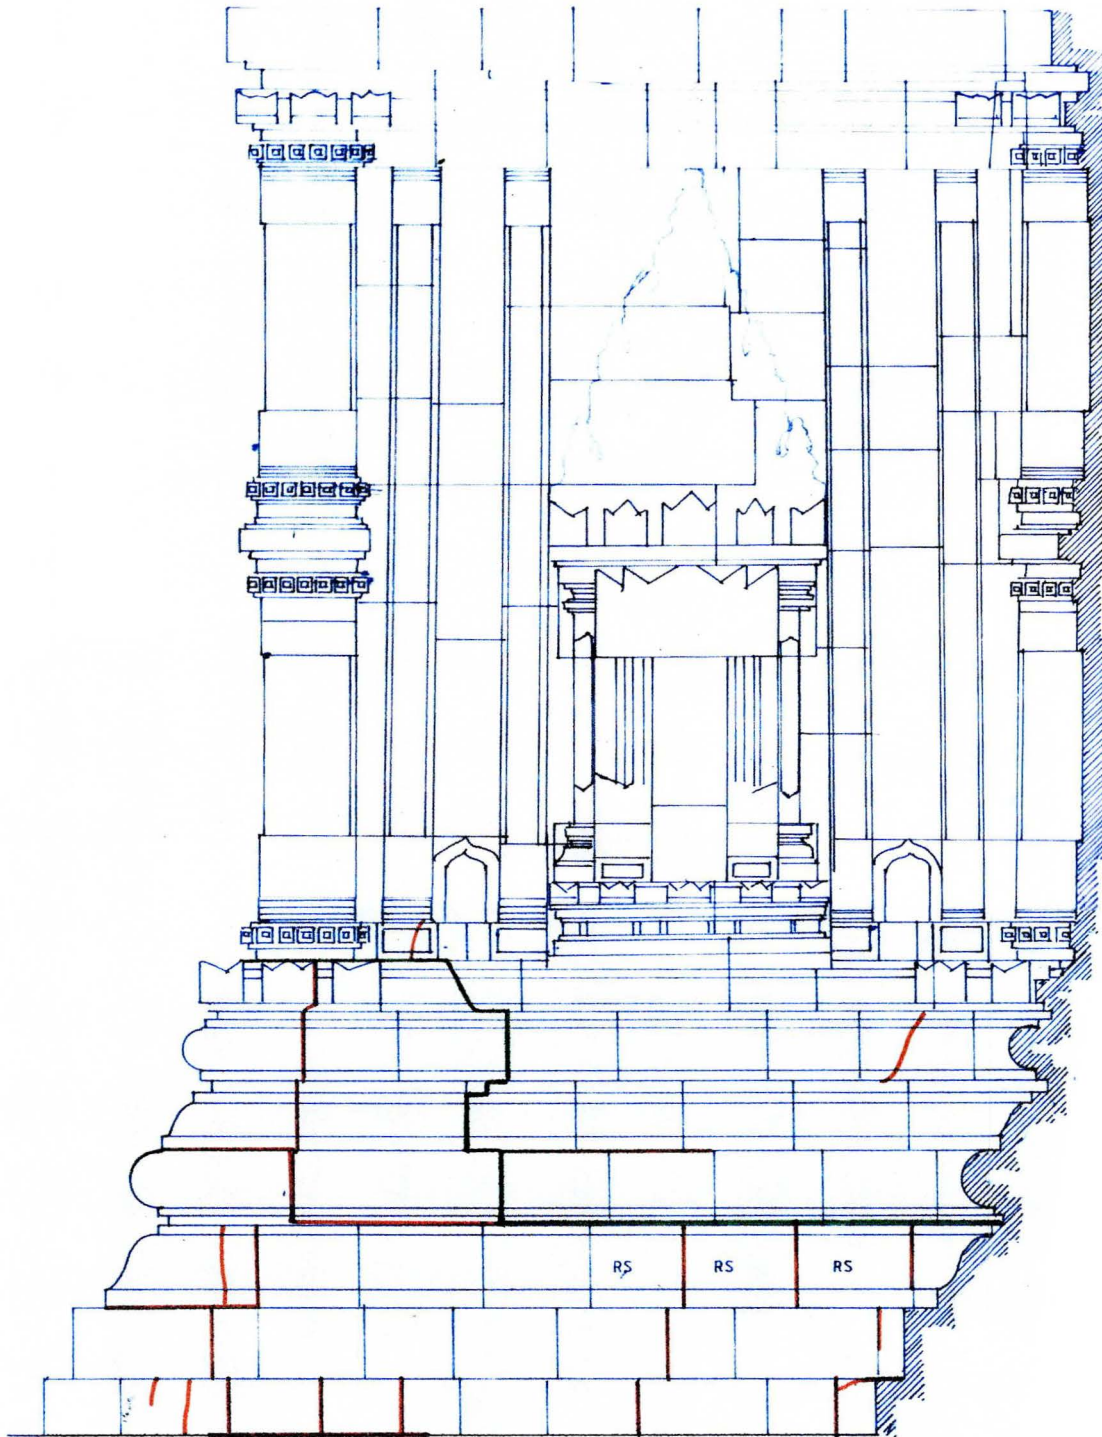
Area V

— Cracking and open joint stone

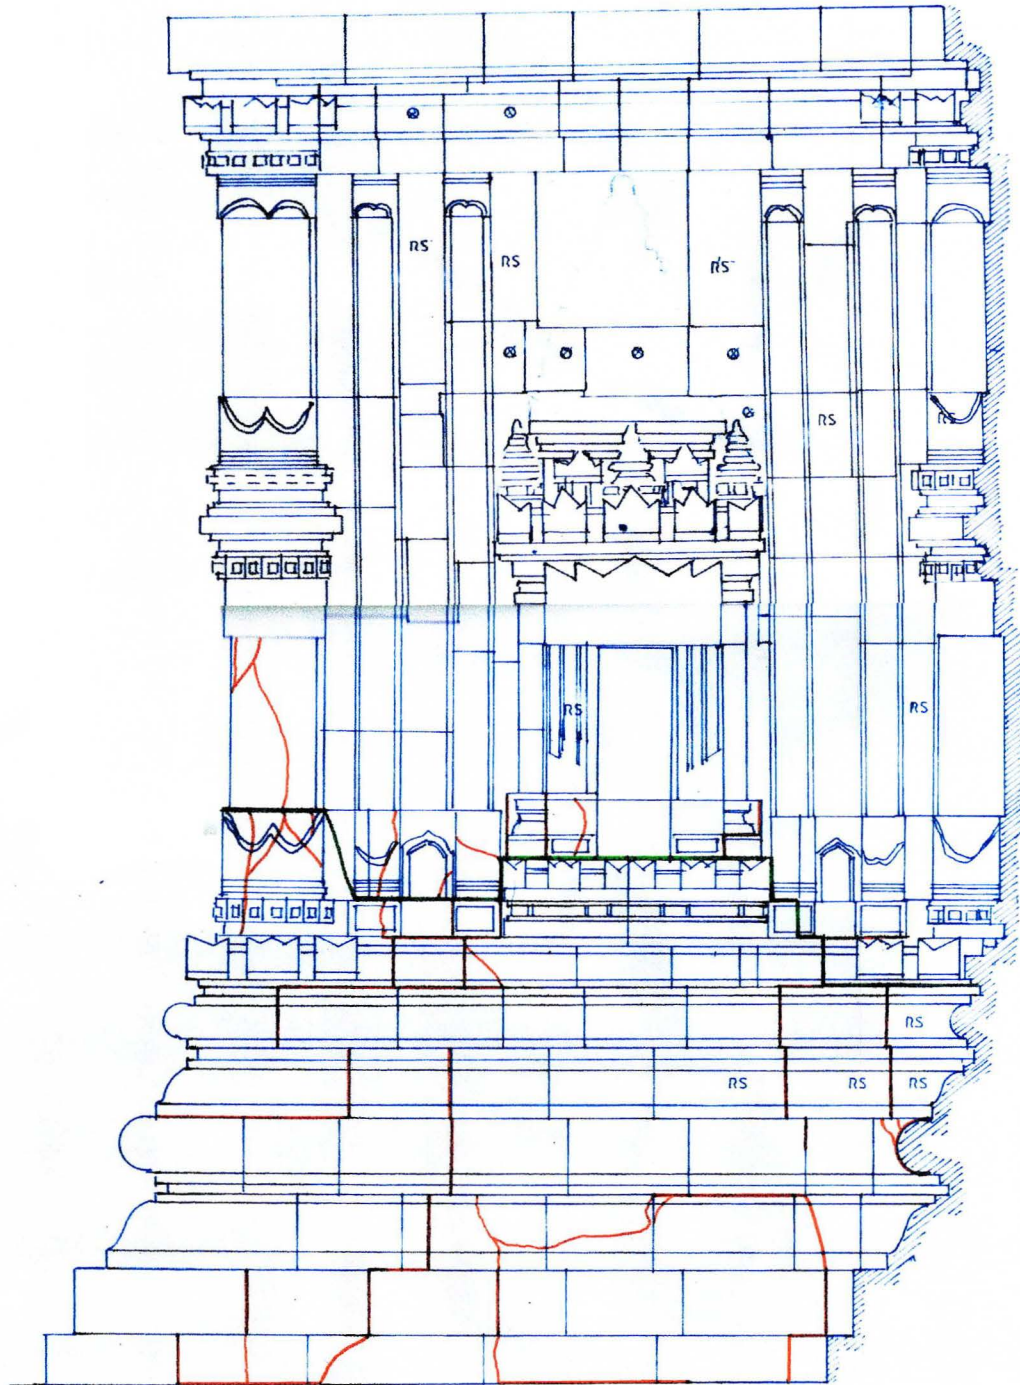
Area VIII

— Cracking and open joint stone

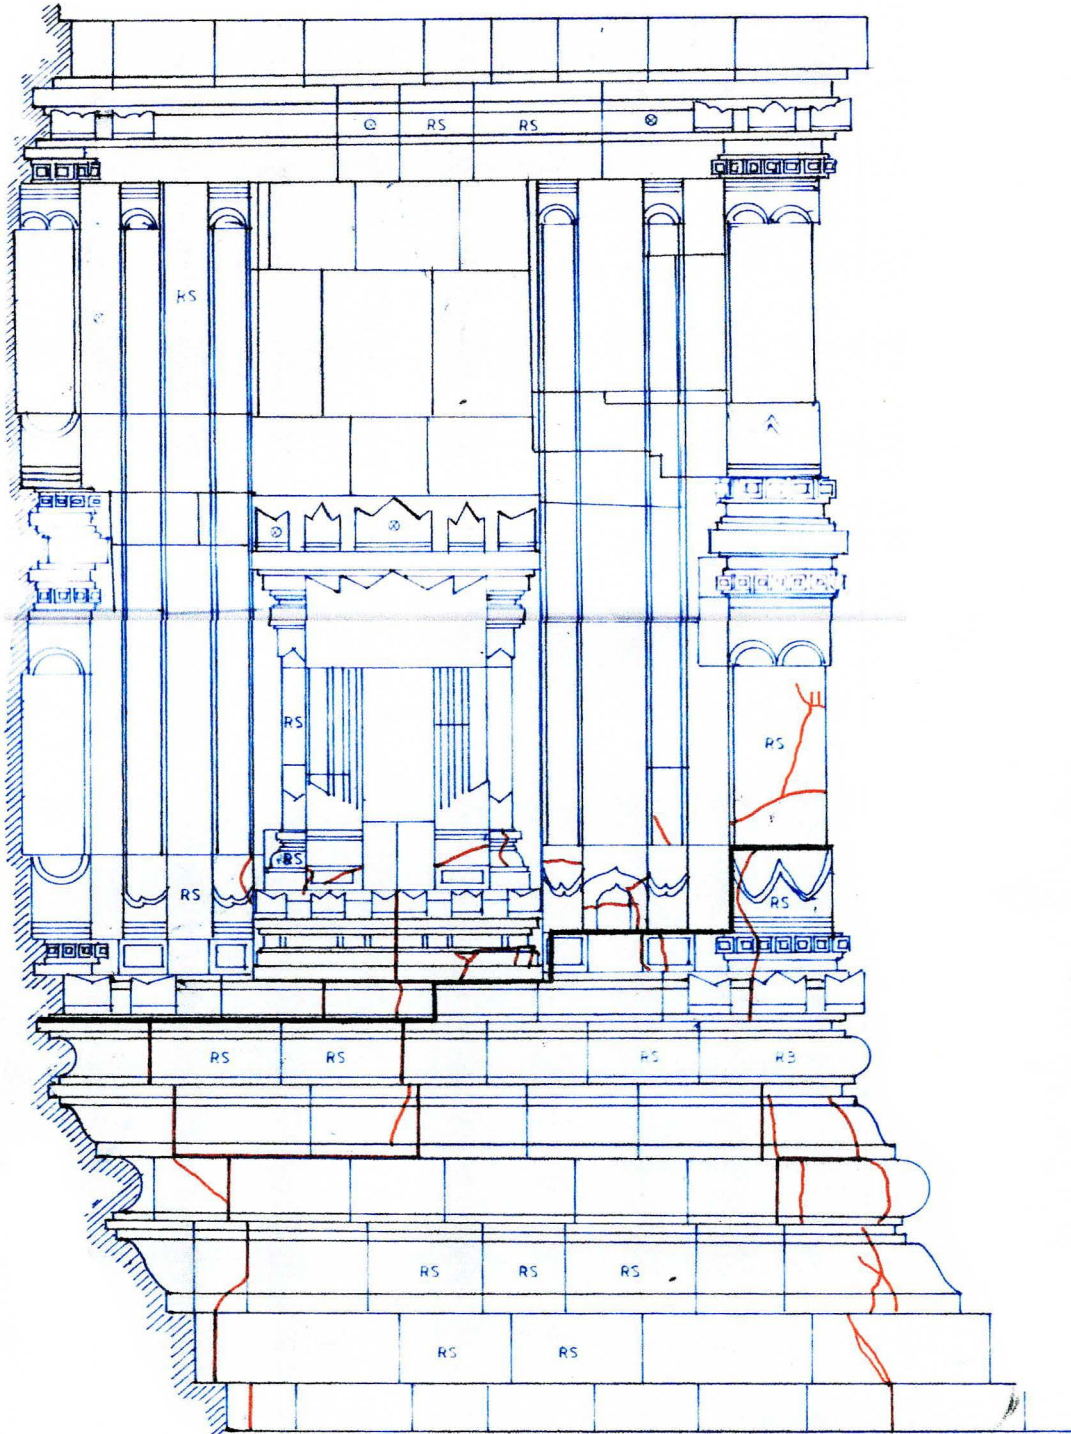
Area 9

— Craking and open joint stone

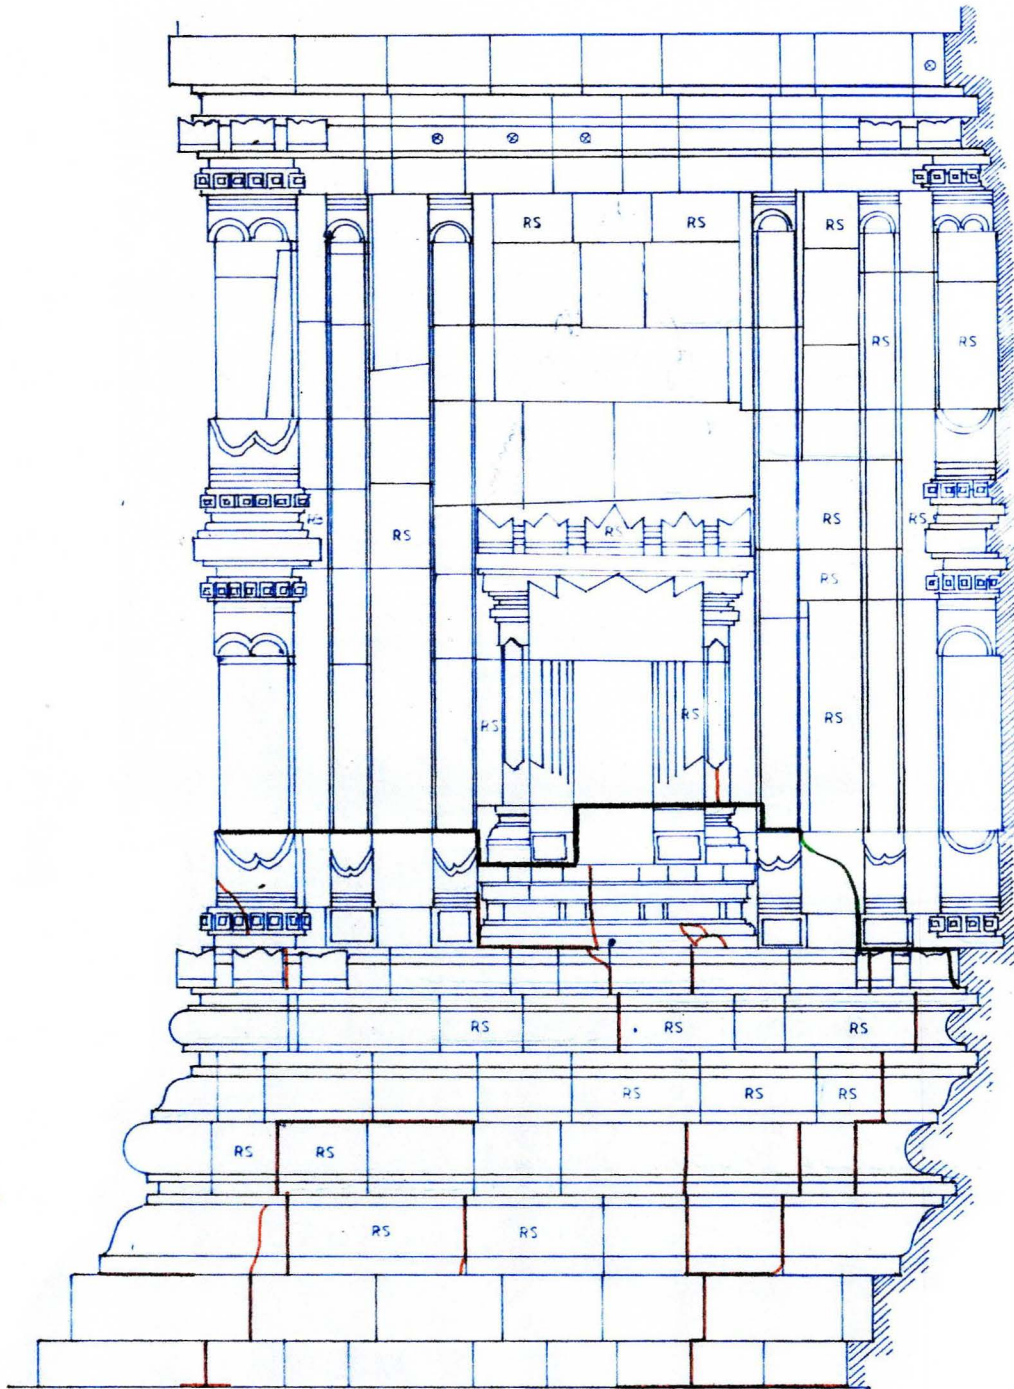
Area X

Cracking and open joint stone

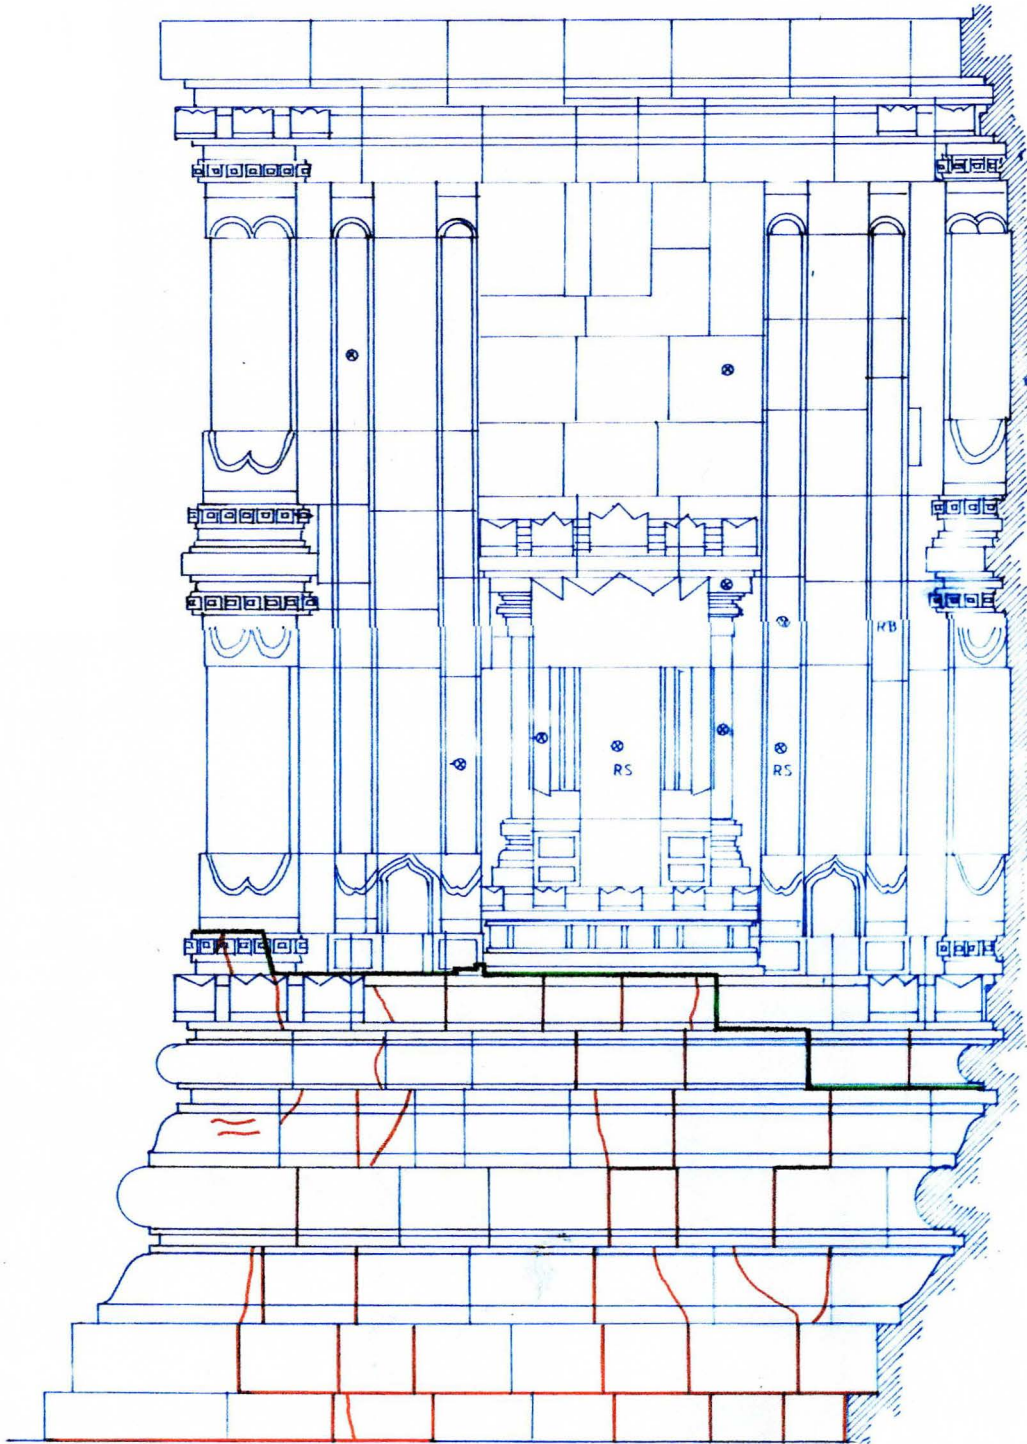
Area XIII

— Cracking and open joint stone

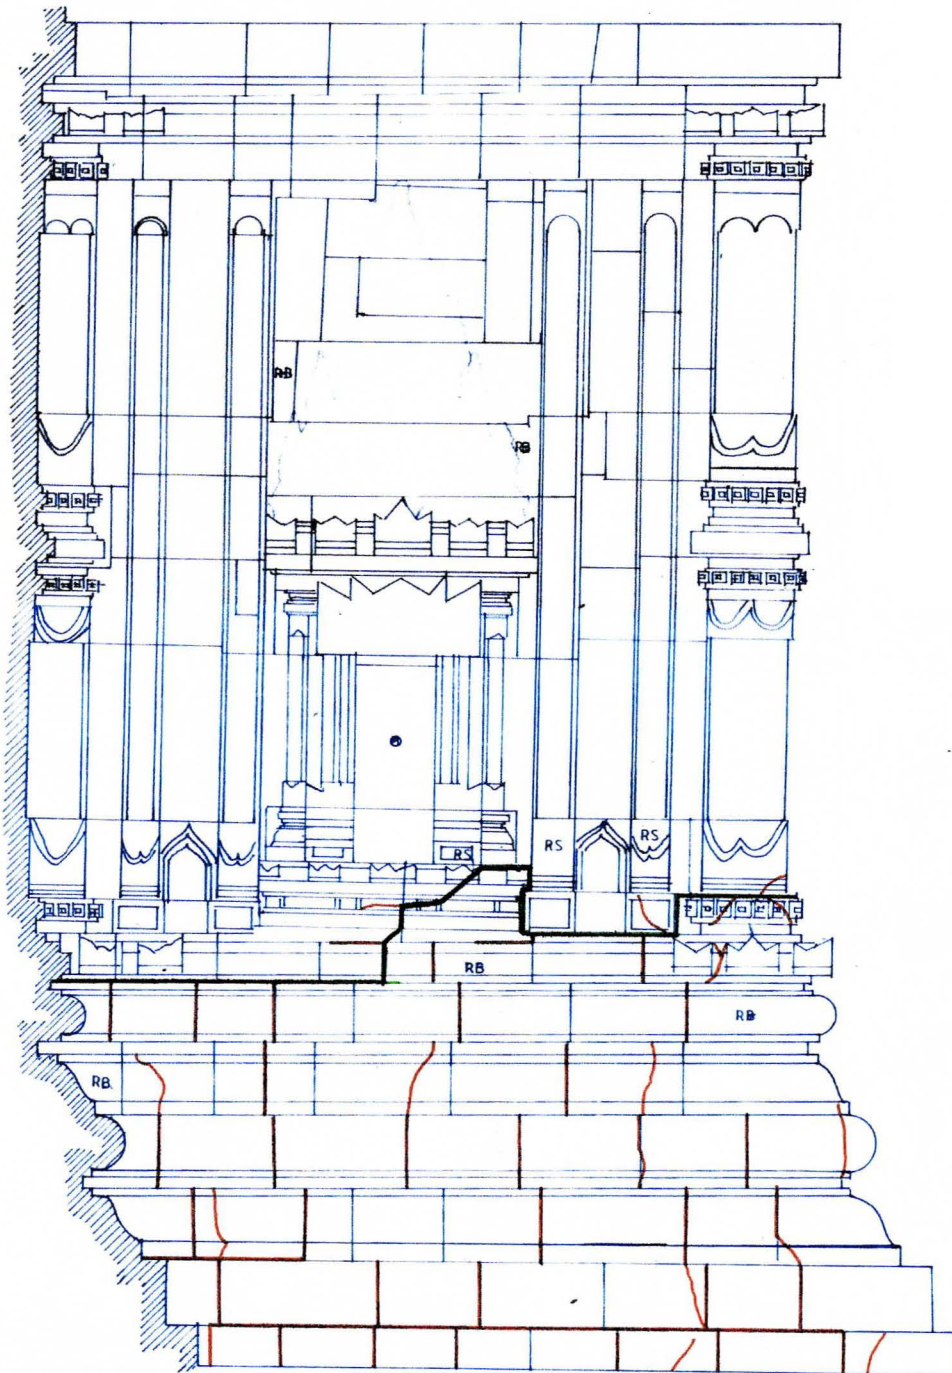
Area XIV

— Cracking and open joint stone
