THE TECHNICAL STUDY ON TAMANSARI AFTER THE EARTHQUAKE

**Technical Study on Taman Sari Water Castle after the
Earthquake 27 May 2006**

**The Archaeological Office of Yogyakarta
2007**

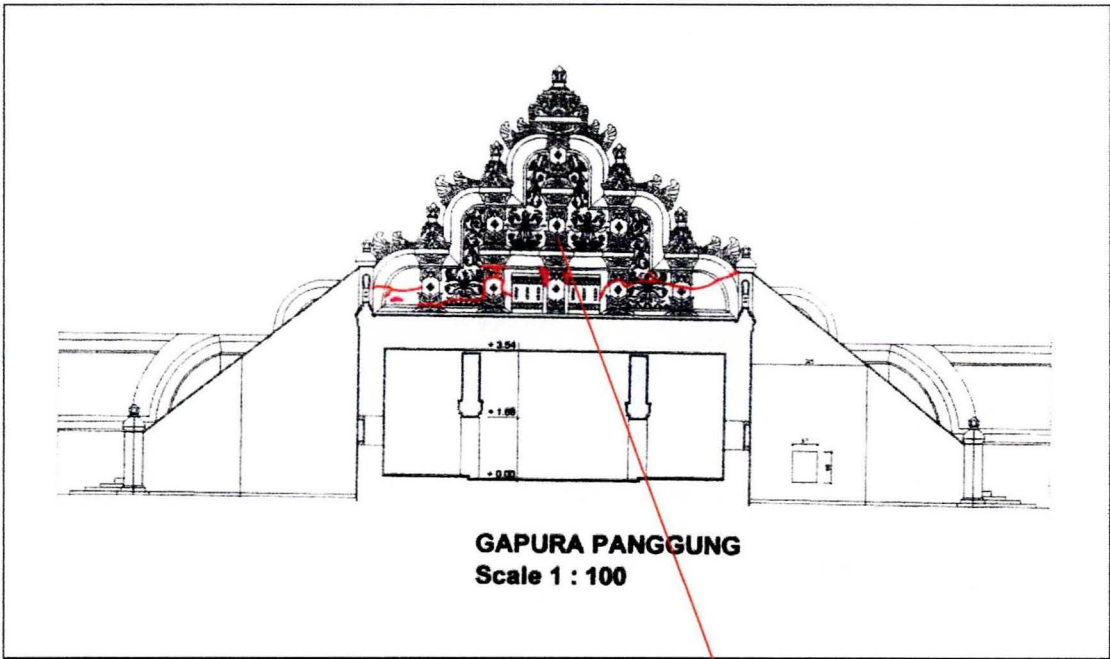
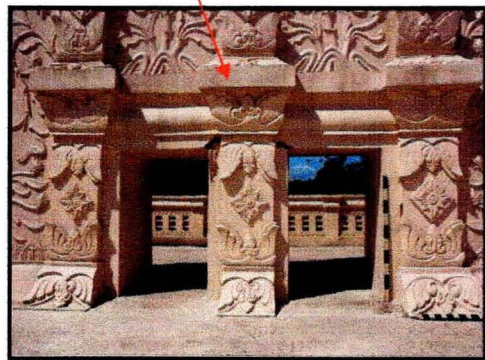
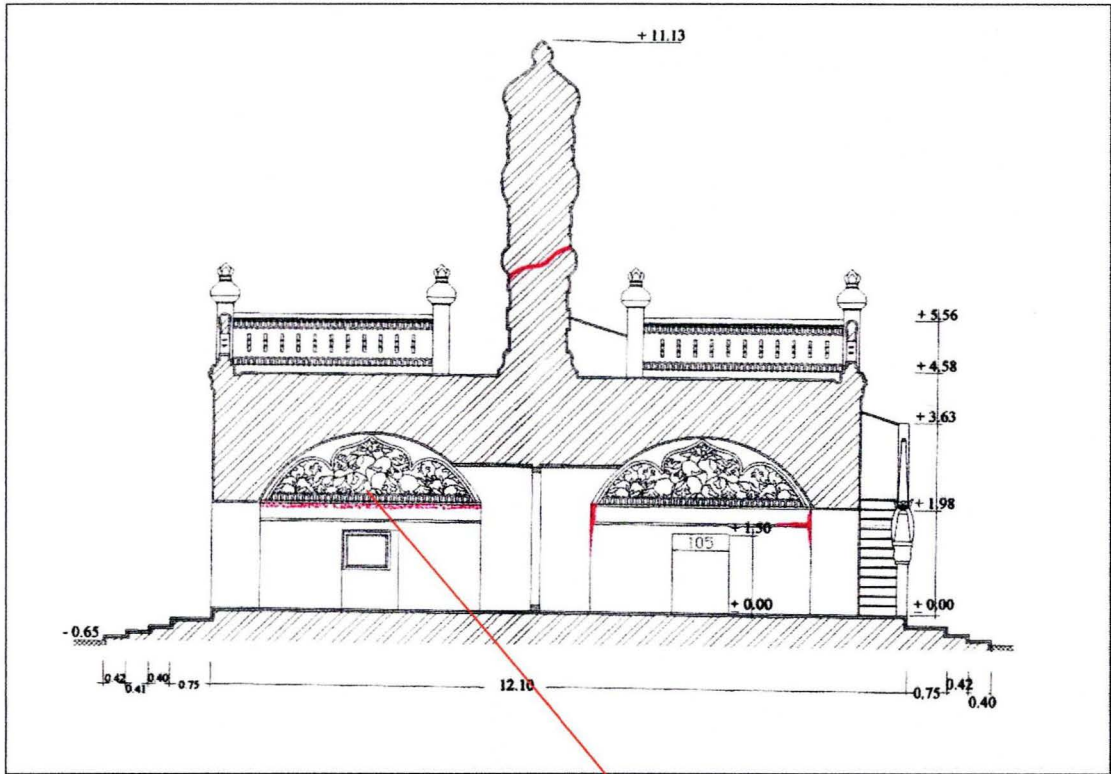
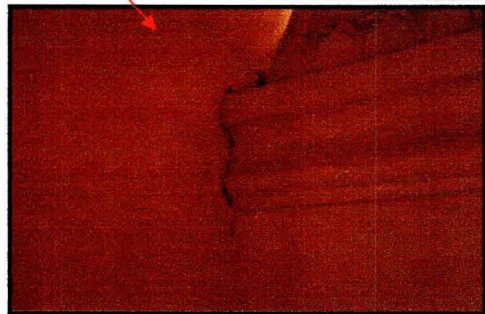
1. Gapura Panggung (Panggung Gate)

The damages after the earthquake are located on the walls of Gapura Panggung (Gapura gate) in the north and south of the entrance gate. There are some peeling on the cement layers. There are cracks (breaking cracks and micro cracks) on the walls and the roof. The cracks on the walls and on the top of the rooms' door especially the cracks which are located on the ornamented walls still in unstable condition. The locations of the cracks are explained in the picture bellow:

- Gapura Agung
- Gapura Panggung
- Pulo Kenanga

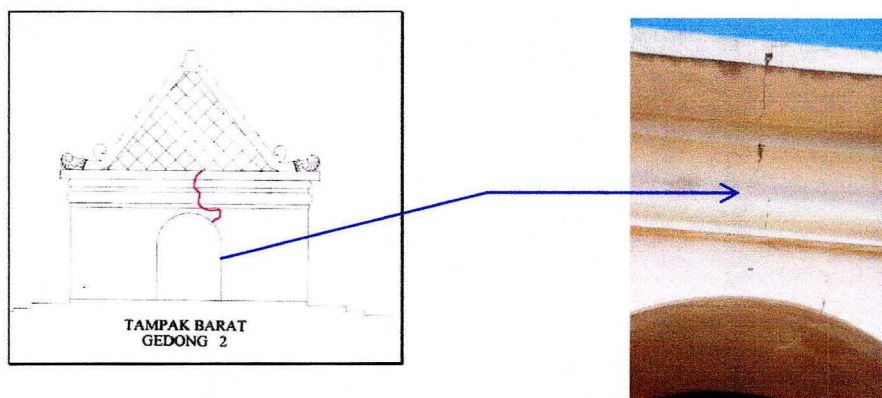
The four buildings have some cracks on the upper wall of the entrance. The cracks are also found on the north and west fences. To observe whether the crack reaches the foundation or not, a test pit is conducted on the inner north and west fence. On the two locations, the walls are breaking while on the north, the upper wall inclines to the south direction. The vertical cracks also occur on the outside wall of Gedong Sekawan's fence wall (on the path to the Pogangan Peksi Beri). Observation states that the crack does not occur in the foundation structure.

Structure crack on the Gedong Sekawan

- The east mosque' fence
- The north side of Gedong Temanten
- The south fence of Gapura Panggung
- Gedong Sekawan on northwest side
- Gedong Sekawan on southwest side

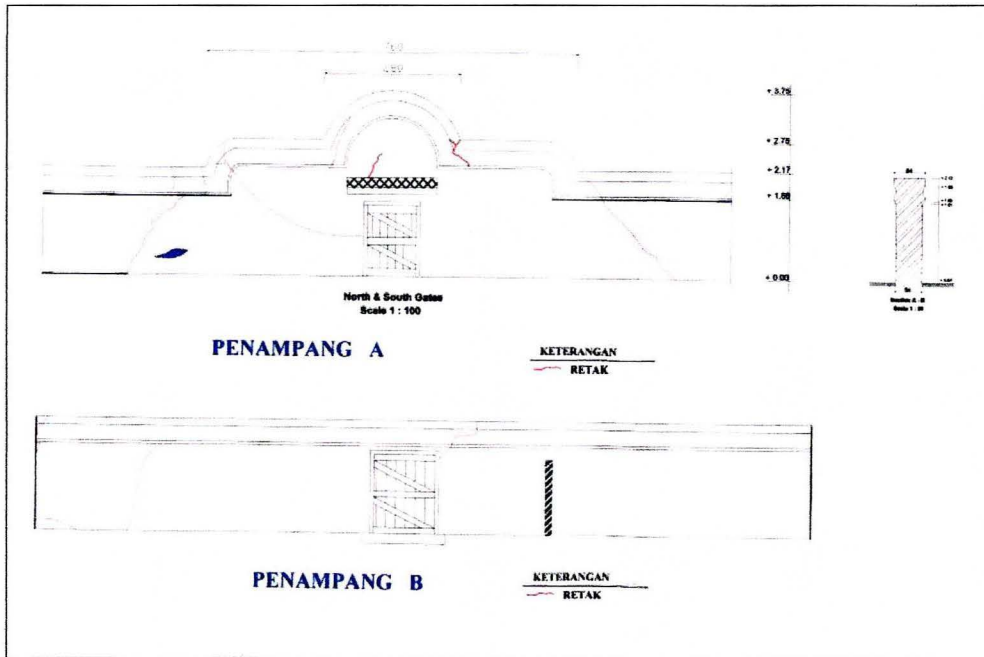
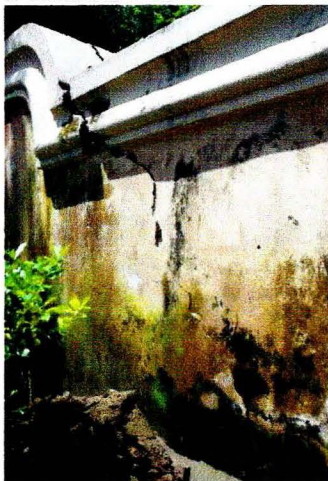
Cracks on the south inner fence structure of the Gedong Sekawan

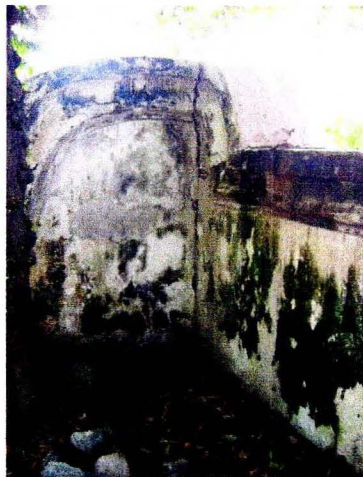
Cracks on the north outer fence structure of the Gedong Sekawan

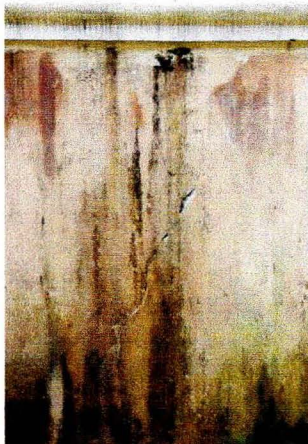
Cracks on the west inner fence structure of the Gedong Sekawan

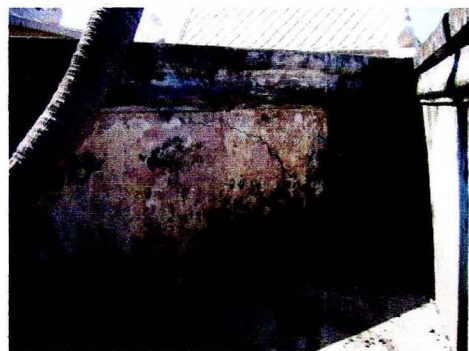
Cracks on the west outer fence structure of the Gedong Sekawan

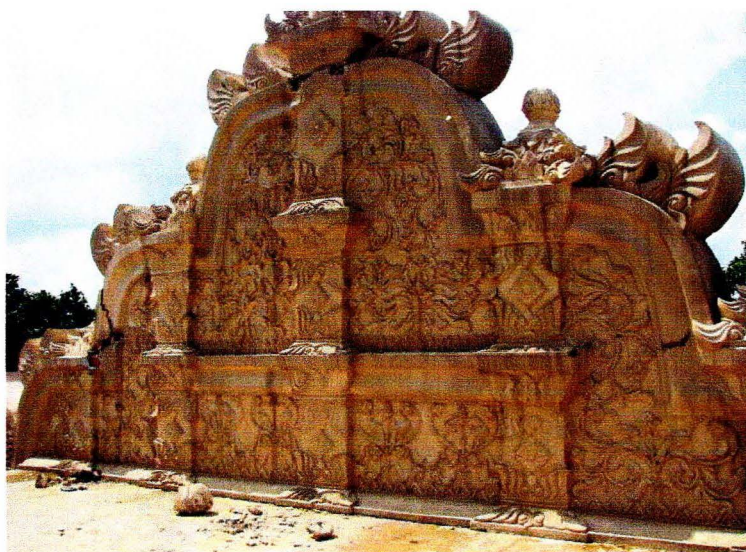
The horizontal cracks can be found in the tympanum (gunungan). The crack has made its top ornament falls down. The earthquake also has made this building inclines to the west side. The damage which needs a serious concern is the structure damage which causes the damage of the top ornament.

The condition of the west gapura agung before the emergency action

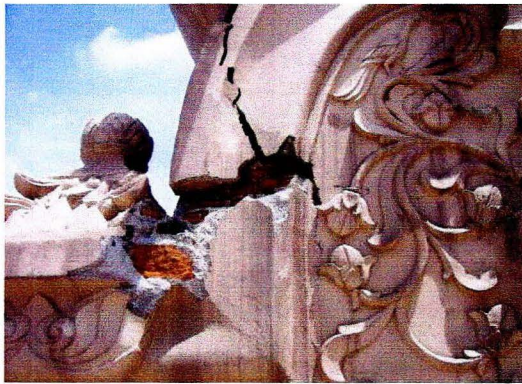
The damage on the north inner wing's corner

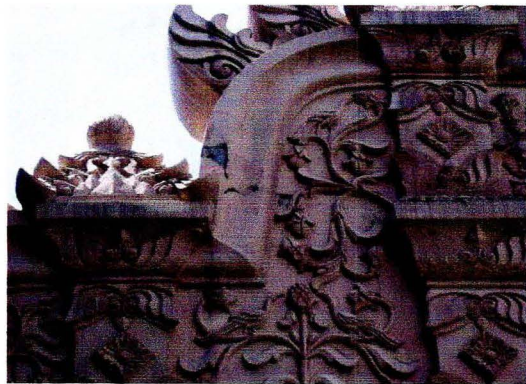
The damage on the south outer wing's corner

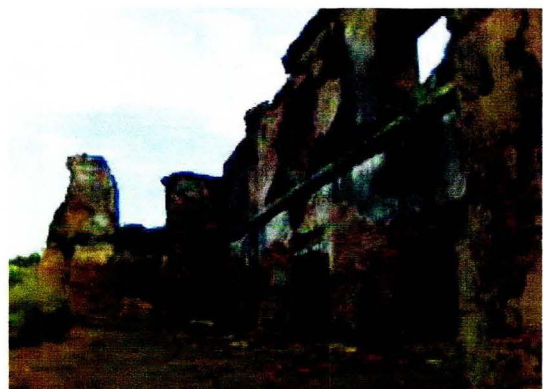
Pulo Kenanga after earthquake

Pulo Kenanga suffered extensive damage after the earthquake in 1867. The earthquake 27 May 2006 had made this building in a worsened condition. The worst damage is in the west part. The ruins of the past earthquake are mix with the ruins of the earthquake 27 May 2006. The structure damages which are caused by the earthquake in 1867 can be observed such as vertical cracks on the walls. To observe the damage on the foundation, an excavation on two location is conducted. The excavation is located in the southeast corner. The heavy damages occur on the upper wall of this corner. The result of the excavation can show that the foundation still in good condition.

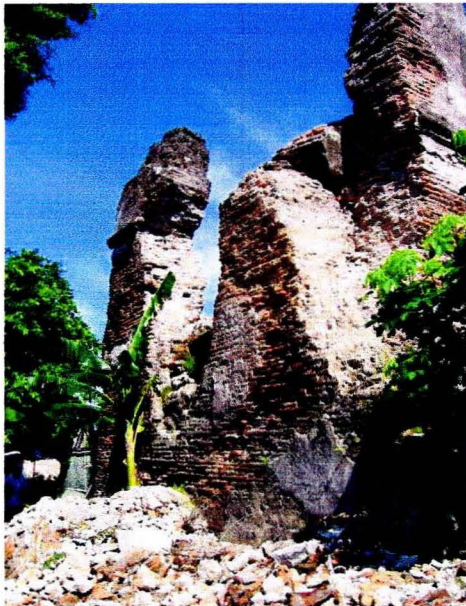
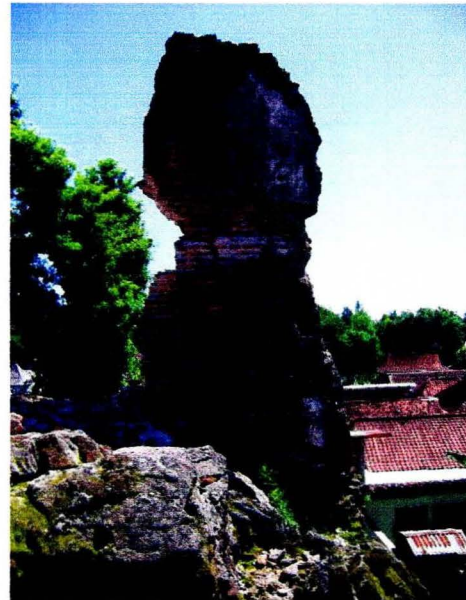
The damage after the 27 May 2006 earthquake on southwest corner of Pulo Kenanga. The left picture - the damage is observed from outside view. The right picture – the damage is observed from the inside view

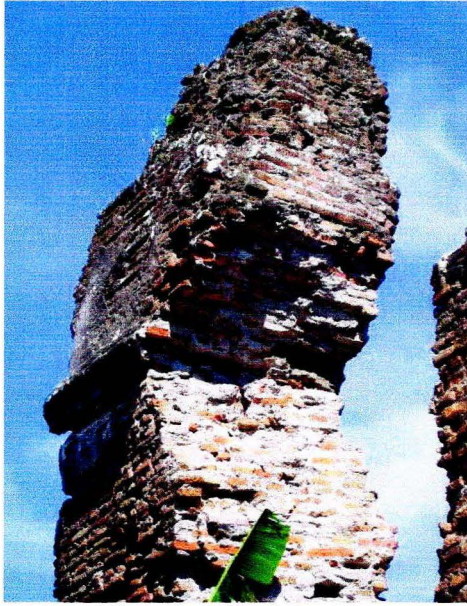
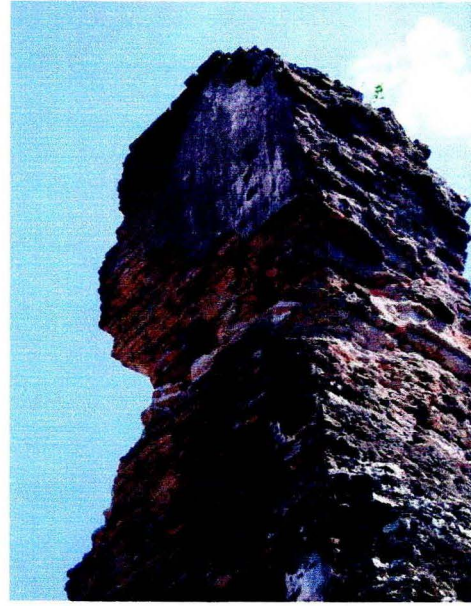
The detail of the dangerous broken structure of the remains
The left picture - from outside view. The right picture – from the inside view

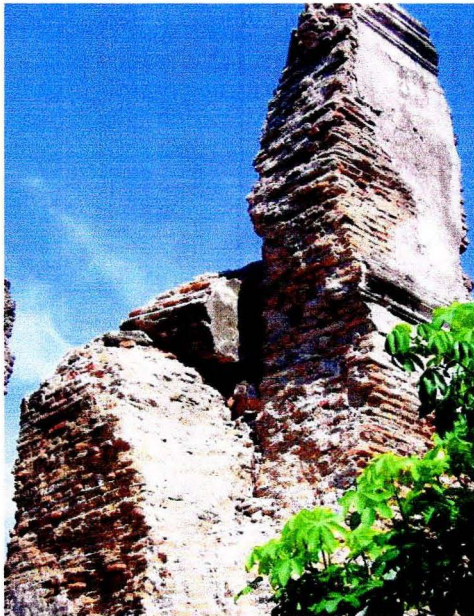
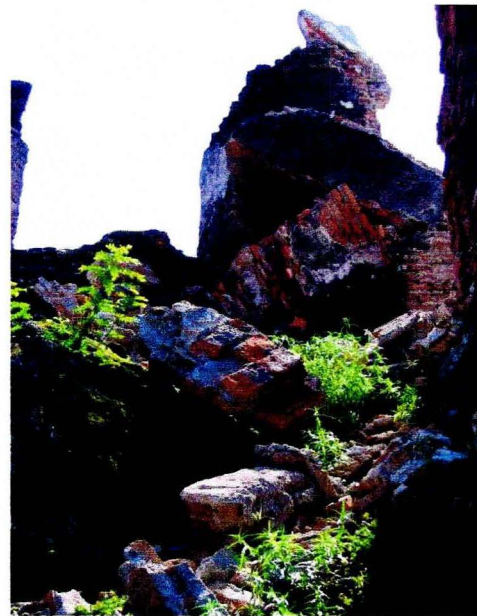
The damage in detail which can endanger people. The left picture - from outside view. The right picture – from the inside view

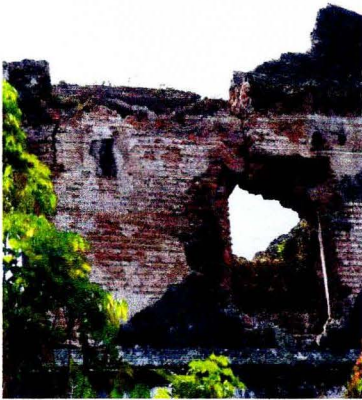
The earthquake on 27 May 2006 also causes damages on the south and north of the entrance gate. The damage on these parts are cracks on the upper wall.

Peeling on the upper wall, cracking on the walls near the window

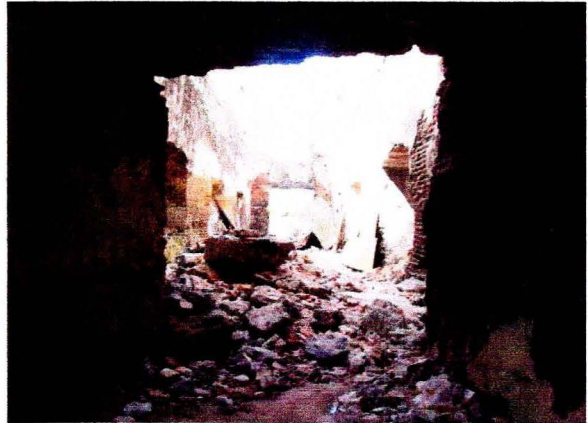
The ruins of the roof

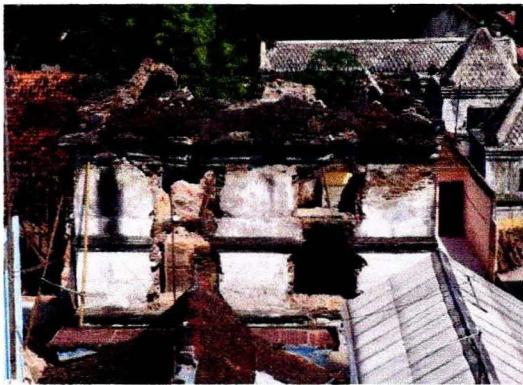
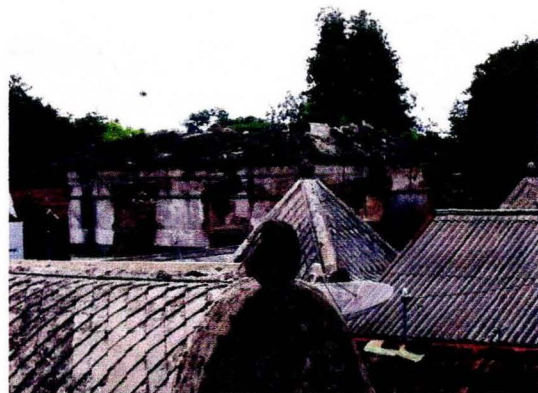
Pulau Panembung is one of the buildings in Taman Sari water castle complex which suffered heavy damage after the earthquake. The resent condition can endanger people who live near the building. Some parts of the roof and the wall near the window collapse after the disaster. The damages reach 18,96 m3.

The condition of Pulo Panembung after the earthquake

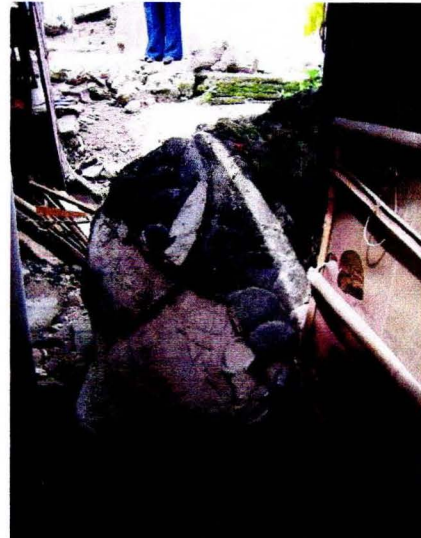
This ex quay building is totally damaged after the earthquake. The buildings which still stand are the terrace and the south wall. The damage's volume reaches 10 m^3 . The building with a bird ornament (*wuwungan*) (the ornament has already collapses when the earthquake on May strikes) suffered cracks. It is assumed that the cracks are old cracks. There are two kinds of cracks. They are cracks that cause the structure breaks and micro cracks. Peeling also occurs in this building. The volume reaches 6 m^2 .

The collapsed Peksi Beri ornament in local people' yard

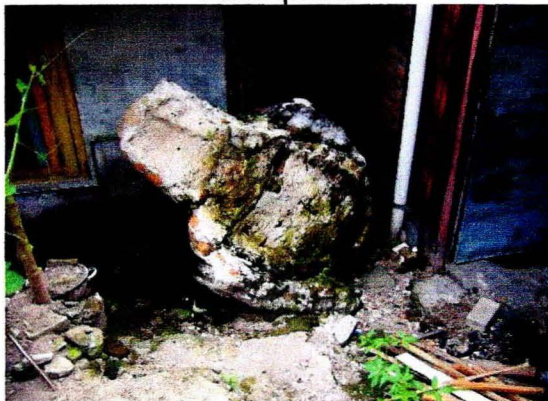
The collapsed pekxi beri in detail

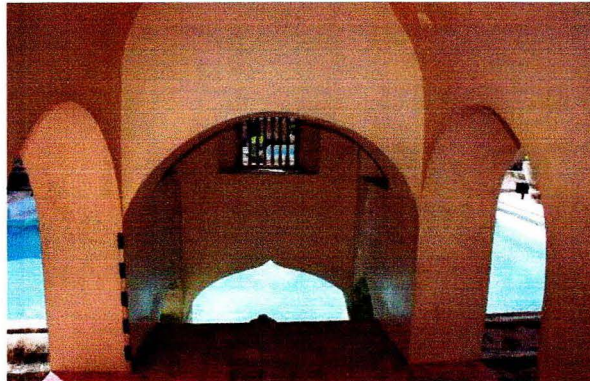
Crack on the wall

The earthquake causes cracks on the pool's wall. The cracks measure 34 m on some parts. The south and south building's wall also crack. The cracking are located on the top on the wall and the wall which direct to the roof.

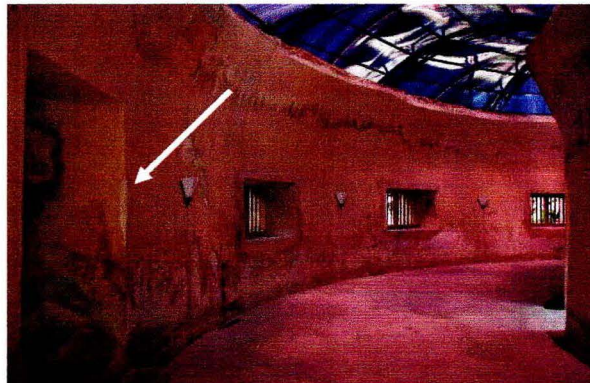
Crack on the Sumur Gumuling's top wall

The damage in this building is breaking on the second floor's wall. The earthquake also causes micro cracks which measure 9,95 m. Peeling on this building measures 105 m².

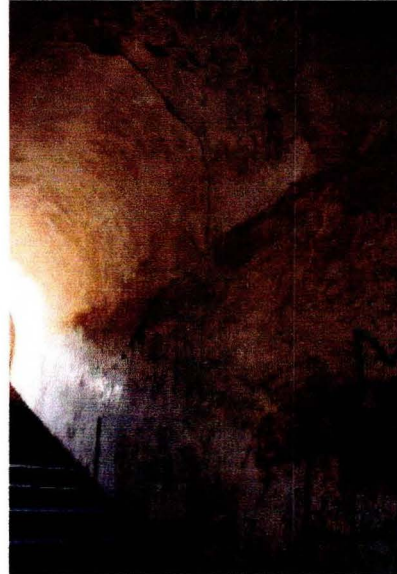
Crack on the top part of urung-urung

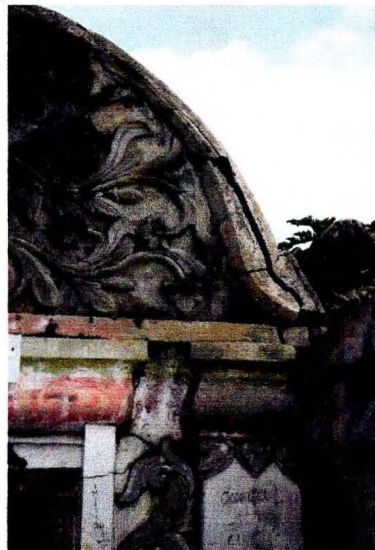
Crack on the south side of urung-urung entrance gate's roof

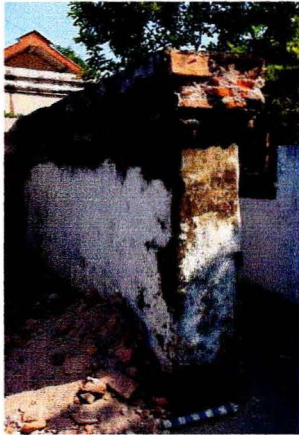
Fortress wall on the north of Gedong Temanten

The fence wall of Gedong Temanten yard breaks and collapses. The beaking wall measures $14,2 \text{ m}$ on some parts while the collapsed structure volume is $0,483 \text{ m}^3$. The wall also inclines to the south direction. The growth of algae on the wall is 26 m^2 while the growth moss is 15 m^2 . The peeling is conducted on the south cracked wall. It is conducted to observe the depth of the crack. The observation result states that the crack does not occur in the structure.

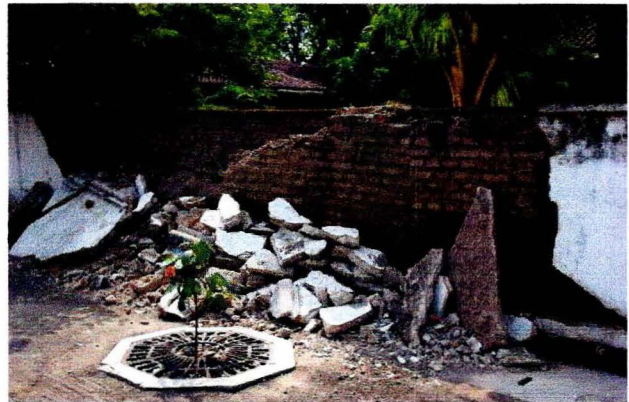
The condition of the wall on the north of Saka Tunggal mosque

The wall on the north of Saka Tunggal mosque collapses after the earthquake ($1,064 \text{ m}^3$). The peeling of this building occurs in the south fence. The peeling measures $4,2 \text{ m}^2$. Wall breaking can be found in the fence which stretches to the south and north. The growth of algae and moss on the wall measures 8 m^2 .

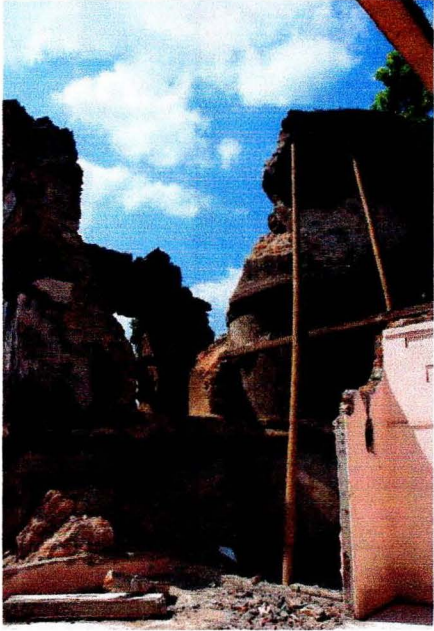
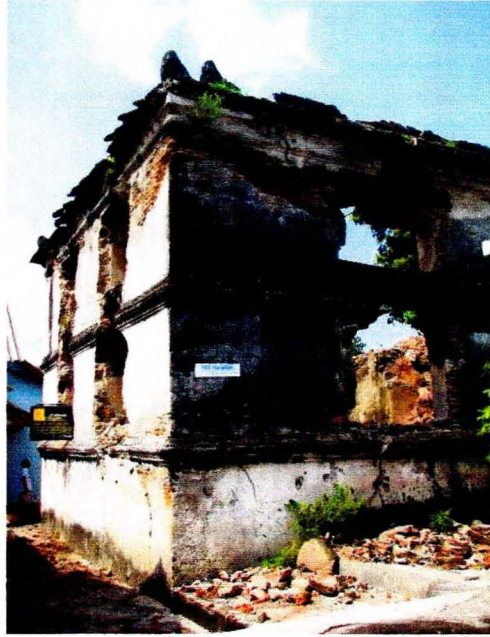
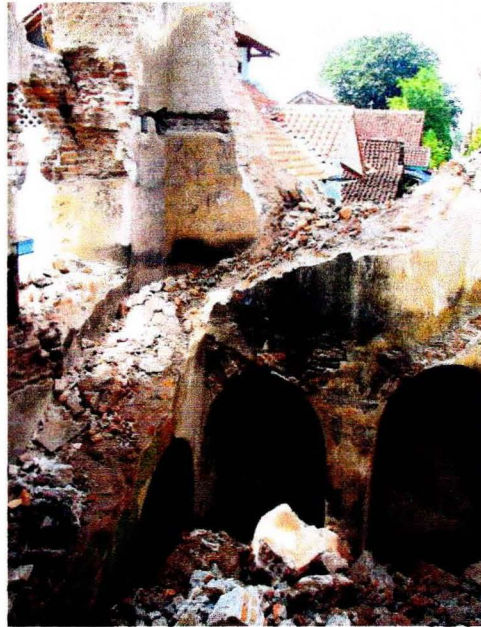
The structure damage on Pulo Panembung
