THE TECHNICAL STUDY ON TAMANSARI AFTER THE EARTHQUAKE

**Technical Study on Taman Sari Water Castle after the
Earthquake 27 May 2006**

**The Archaeological Office of Yogyakarta
2007**

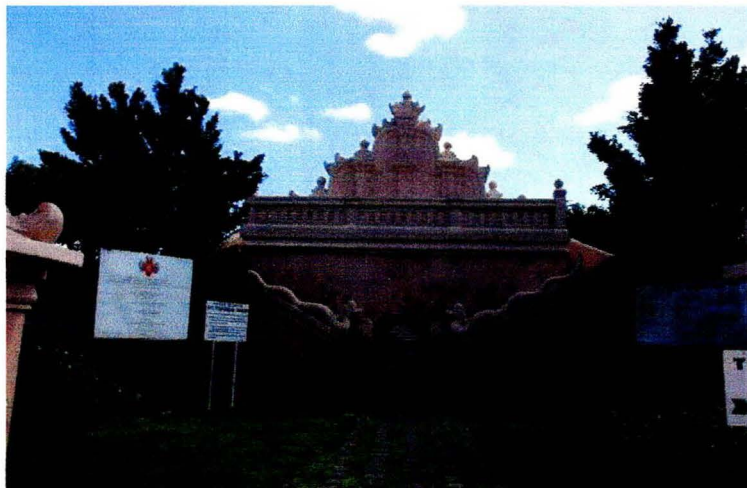
1. Gapura Panggung (Panggung Gate)

The damages after the earthquake are located on the walls of Gapura Panggung (Gapura gate) in the north and south of the entrance gate. There are some peeling on the cement layers. There are cracks (breaking cracks and micro cracks) on the walls and the roof. The cracks on the walls and on the top of the rooms' door especially the cracks which are located on the ornamented walls still in unstable condition. The locations of the cracks are explained in the picture bellow:

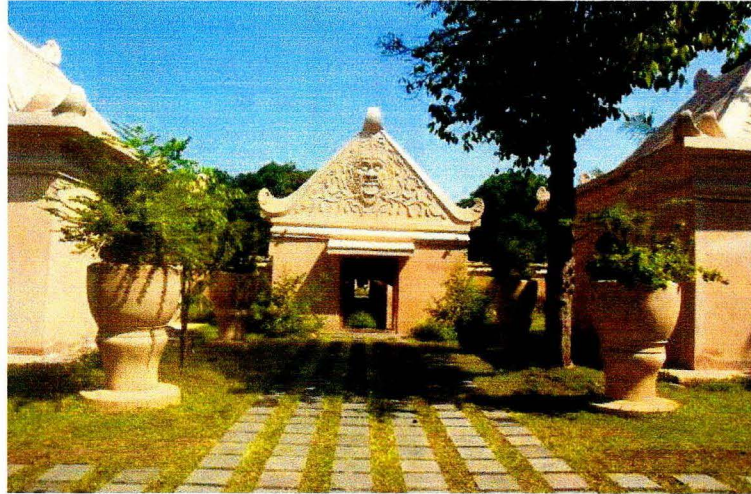
2. Gedong Sekawan

The four buildings have some cracks on the upper wall of the entrance. The cracks are also found on the north and west fences. To observe whether the crack reaches the foundation or not, a test pit is conducted on the inner north and west fence. On the two locations, the walls are breaking while on the north, the upper wall inclines to the south direction. The vertical cracks also occur on the outside wall of Gedong Sekawan's fence wall (on the path to the Pogangan Peksi Beri). Observation states that the crack does not occur in the foundation structure.

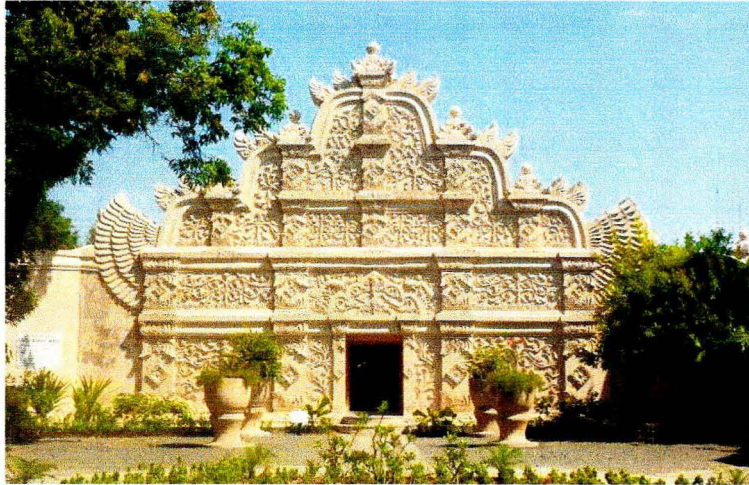
Gapura Agung before the earthquake

The horizontal cracks can be found in the tympanum (gunungan). The crack has made its top ornament falls down. The earthquake also has made this building inclines to the west side. The damage which needs a serious concern is the structure damage which causes the damage of the top ornament.

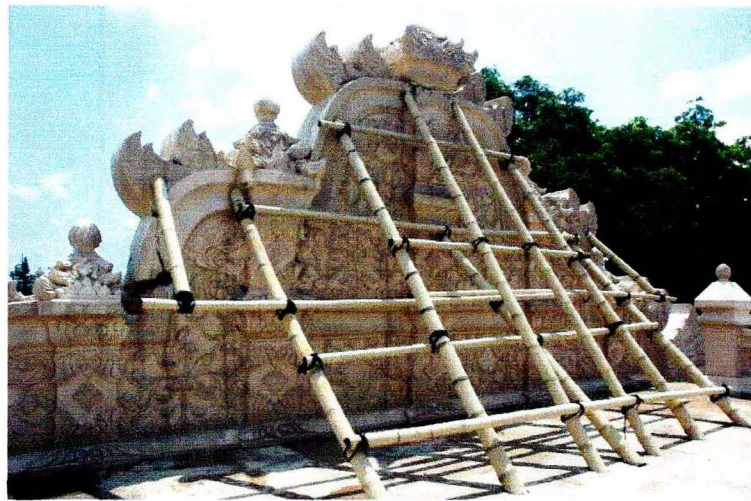
The condition of the gapura agung after the emergency action

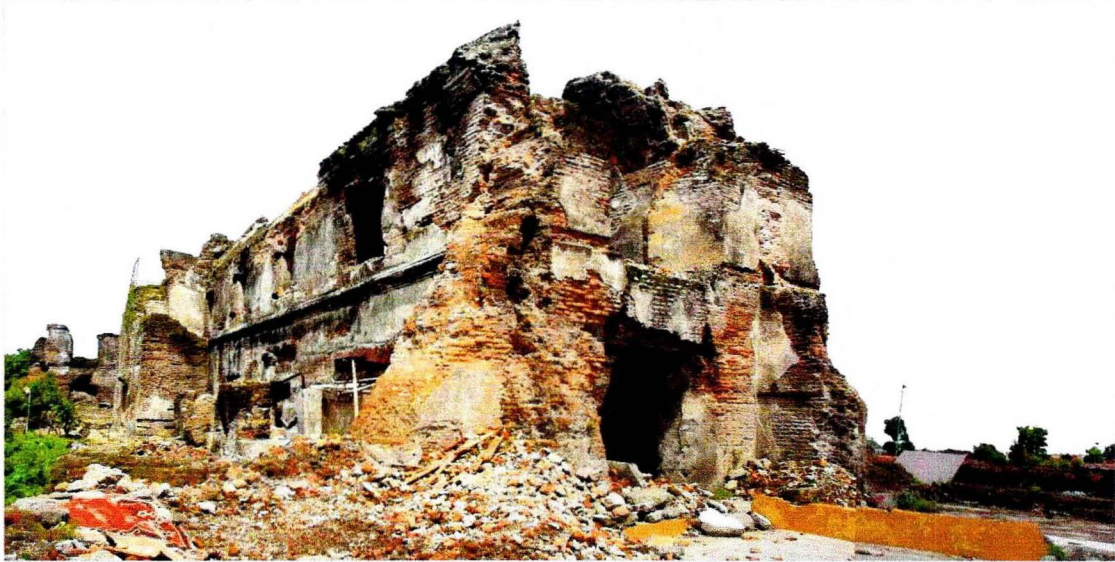
The condition of Pulo Kenanga from northeast view

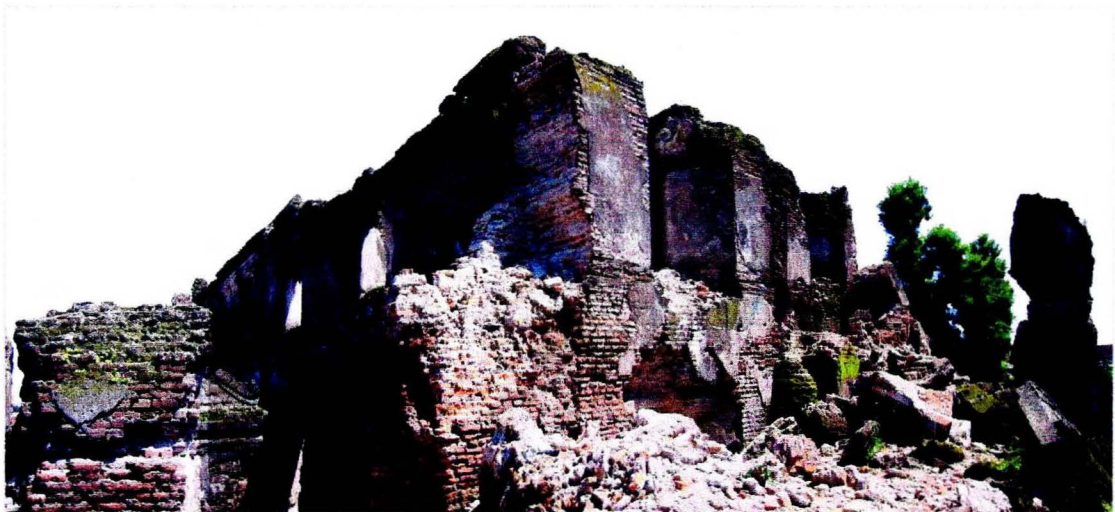
The condition of Pulo Kenanga from southwest view

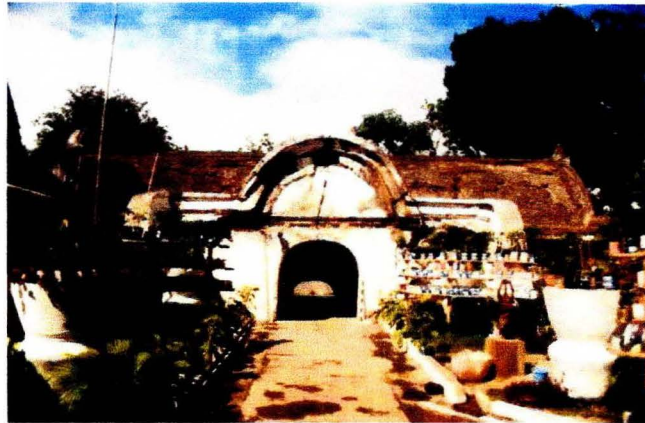
Gerbang Carik from the north view

Crack can be found on one of the north room in the west area. The crack directs to the roof. The west fence's wall of Gerbang carik suffers 20 m horizontal crack. The peeling is also founded on the bathroom' wall near the well.
